Investigation of Fire Impact on Structural Steel through Case Studies

A Thesis Report

WORCESTER POLYTECHNIC INSTITUTE

Date: May 4, 2006

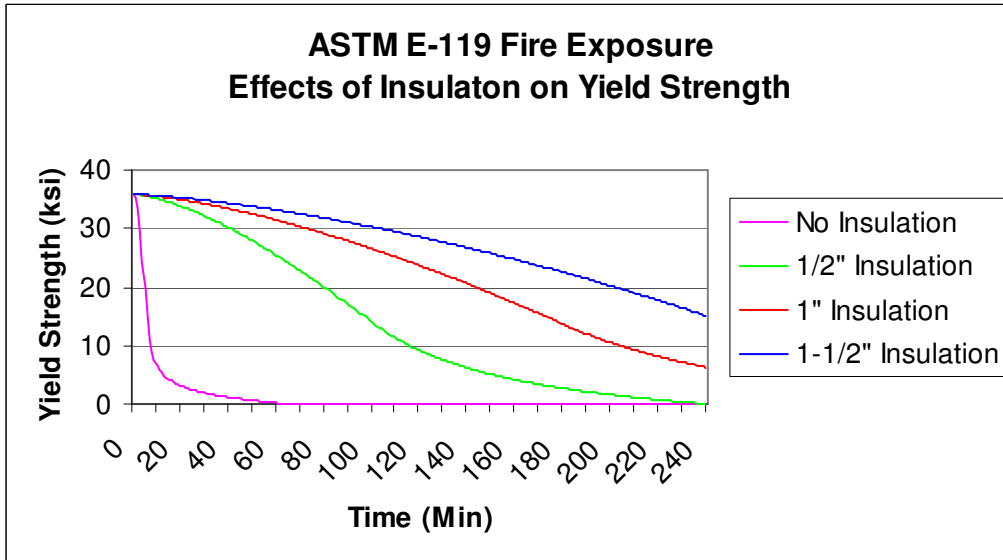
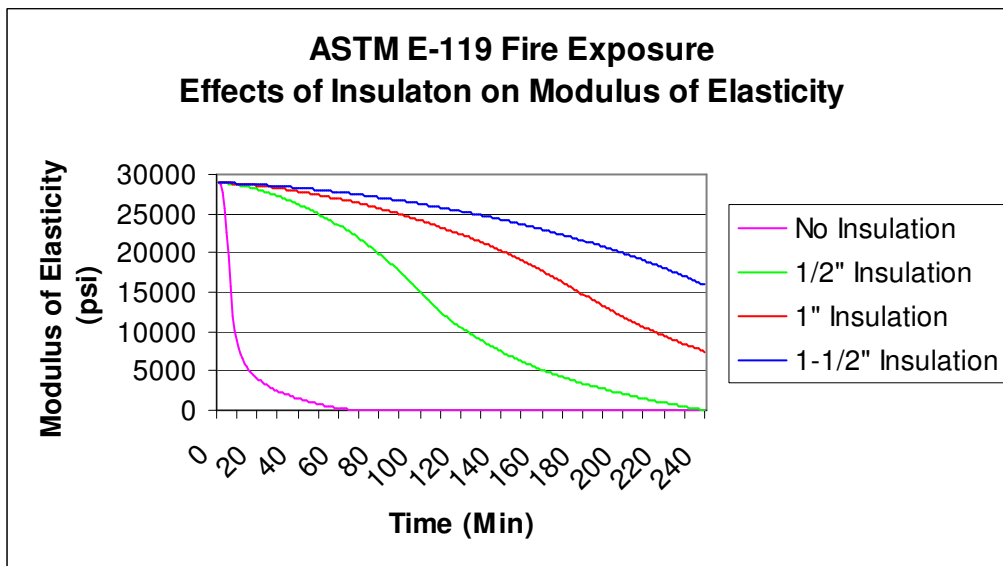
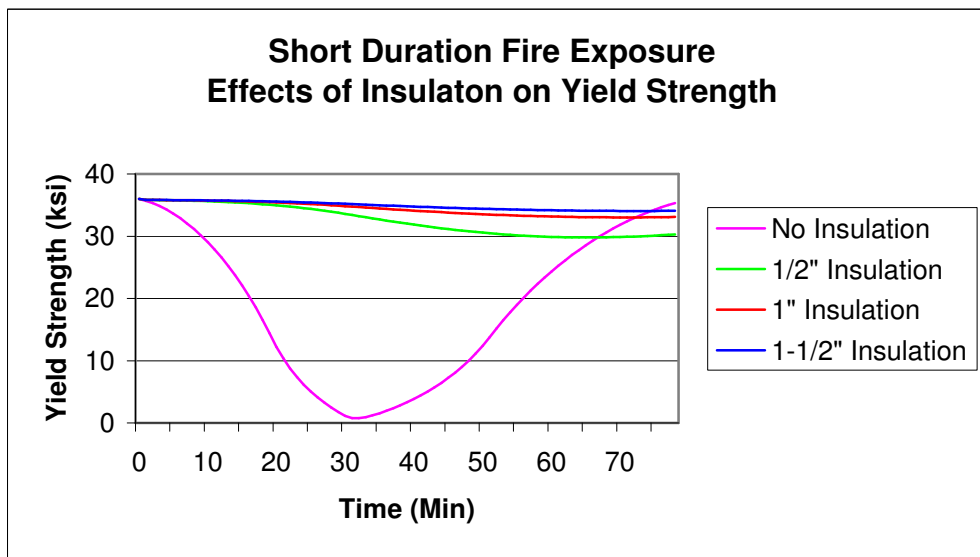
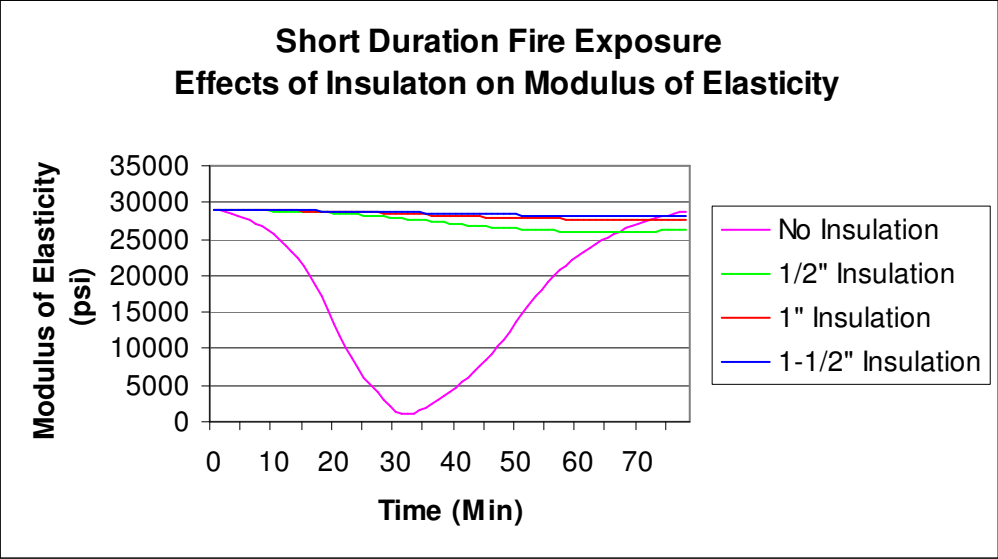
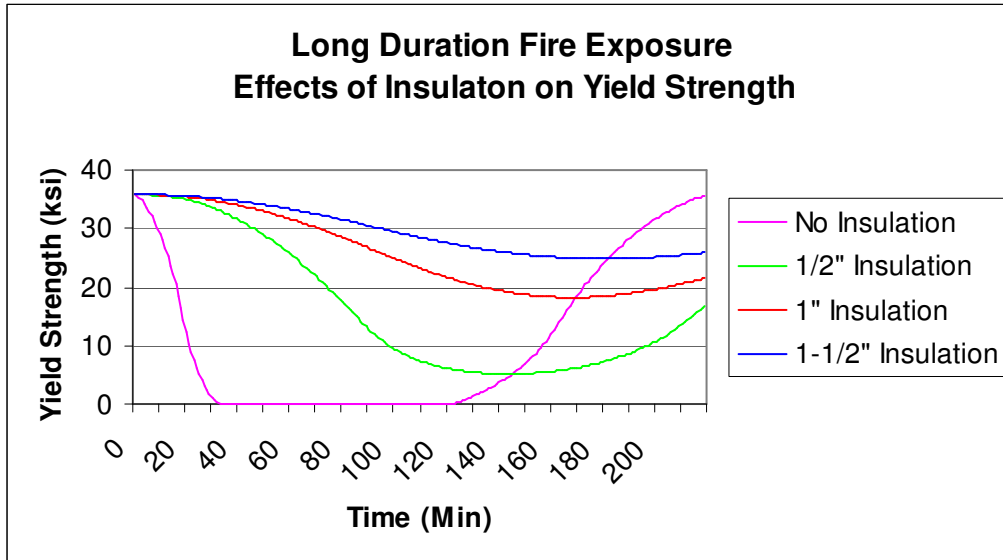
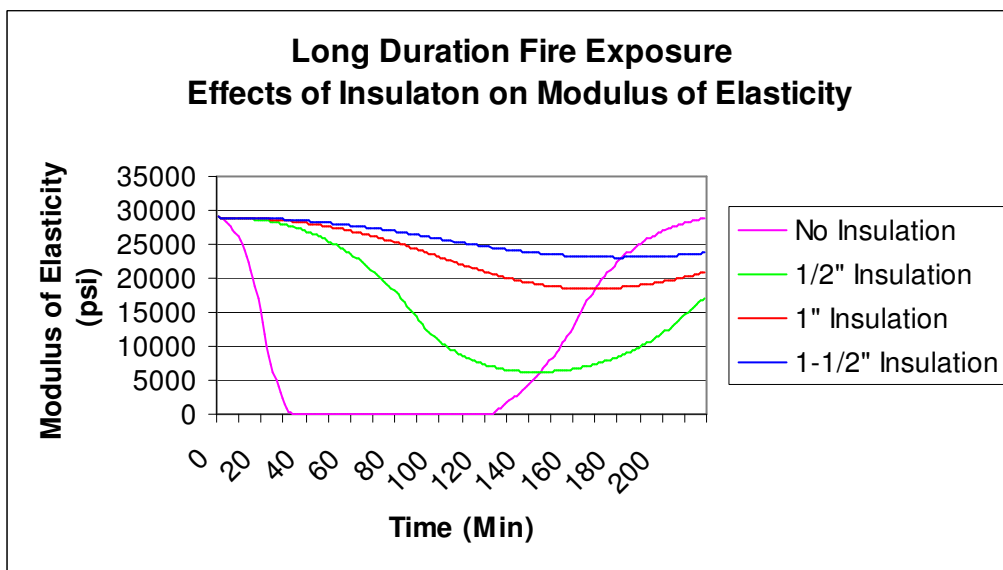
Figure 53 - Effects of Insulation Thickness on Yield Strength

Figure 54 - Effects of Insulation Thickness on Modulus of Elasticity

Figure 56 - Effects of Insulation on Yield Strength

Figure 57 - Effects of Insulation on Modulus of Elasticity

Figure 59 - Effects of Insulation on Yield Strength

Figure 60 - Effects of Insulation on Modulus of Elasticity

The yield strength (F_y) and modulus of elasticity (E) of the steel truss are important factors, because when these values are reduced, the strength of the steel is reduced, which could lead to failure. In all three cases, after one hour (approximate time of failure) with $\frac{1}{2}$ " insulation the loss of yield strength would have been 10 ksi as compared with the truss with no insulation that would have lost approximately all of its strength. Similarly, for the moduli of elasticity graphs, the loss for the ASTM E-119 and long duration fires is 5000 psi after one hour. For the short duration fire the loss is about 4000 psi for $\frac{1}{2}$ " insulation thickness. The loss for the cases with more insulation is less than that for the $\frac{1}{2}$ " insulation thickness. Under the short and long duration fire exposures one can see that the truss without insulation regains strength as the fire decays. This is true to a certain extent but unlike the graph depiction, it will never regain its full capacity. The graphs are off because the equations used to calculate these values (Equations 6-9) only account for temperature and no other factors.

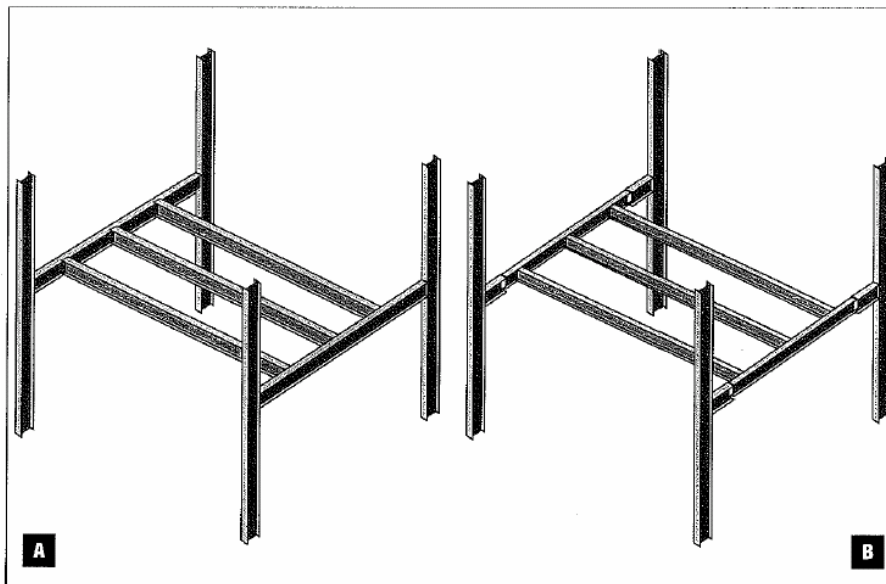
Figure 62 - Interior Bay Framing of WTC 5 (Barnett, 2002)

Figure 4-3 Typical interior bay framing in WTC 5. (A) Floor 9 and roof level. (B) Floors 4, 5, 6, 7, and 8.

From the investigative report of this failure, it was determined that the shear tab connections failed due to secondary tensile forces developed from catenary action. However, in order to come to this conclusion and to provide a thorough understanding of the failure, a much more in depth analysis was performed. The analysis began with investigating the drop-span section of the column tree assembly for bending capacity and deflection as a function of time and temperature (calculated using the equations presented in Section 2.1.2). This same analysis was then done for the two alternative situations of continuous W24x61 and W18x50 girders replacing the column tree assembly.

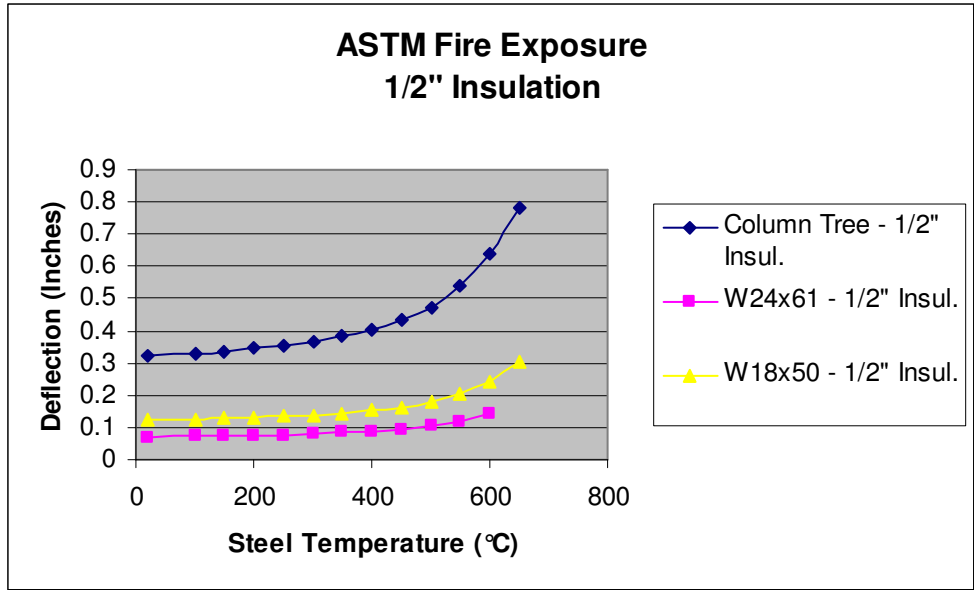
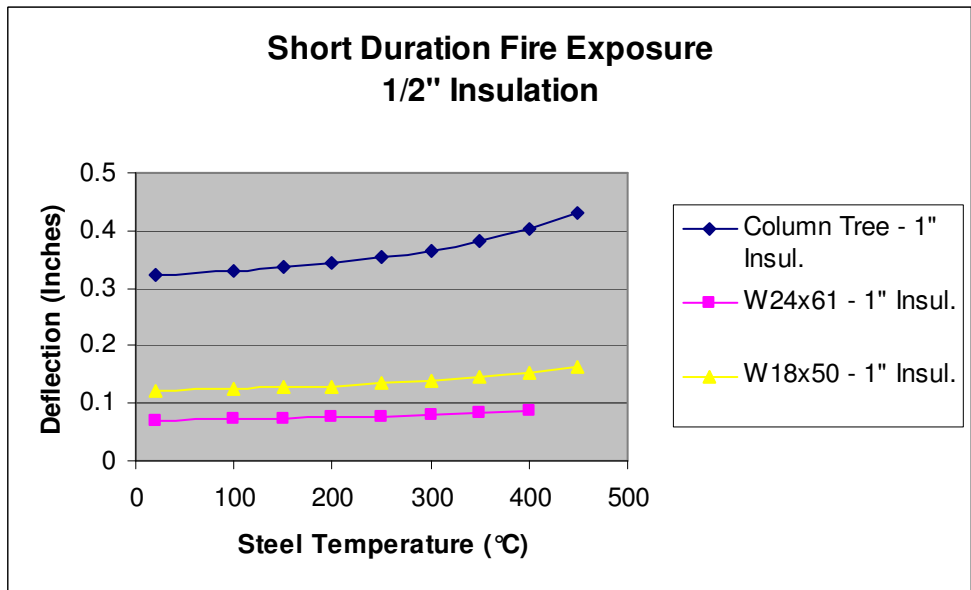
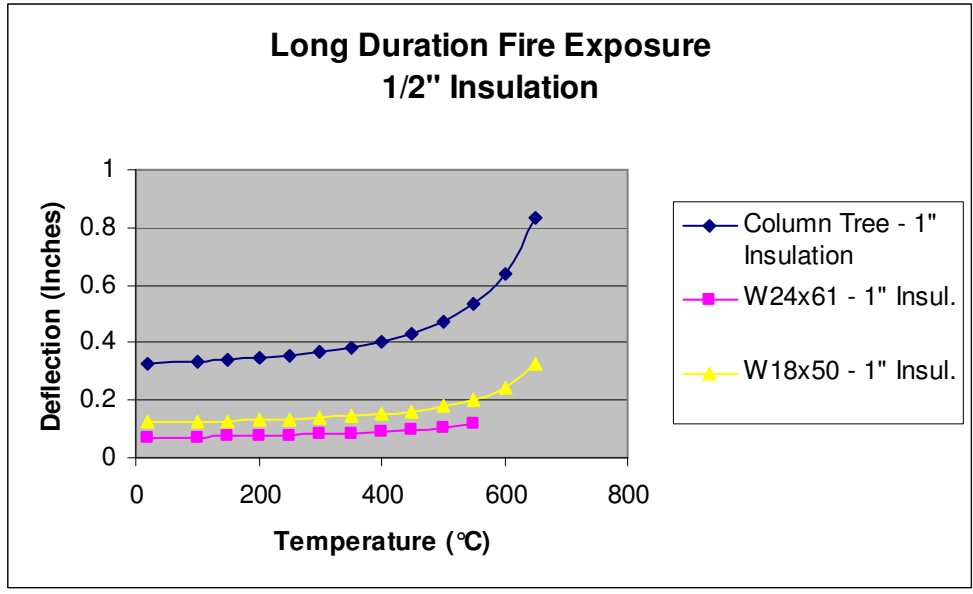
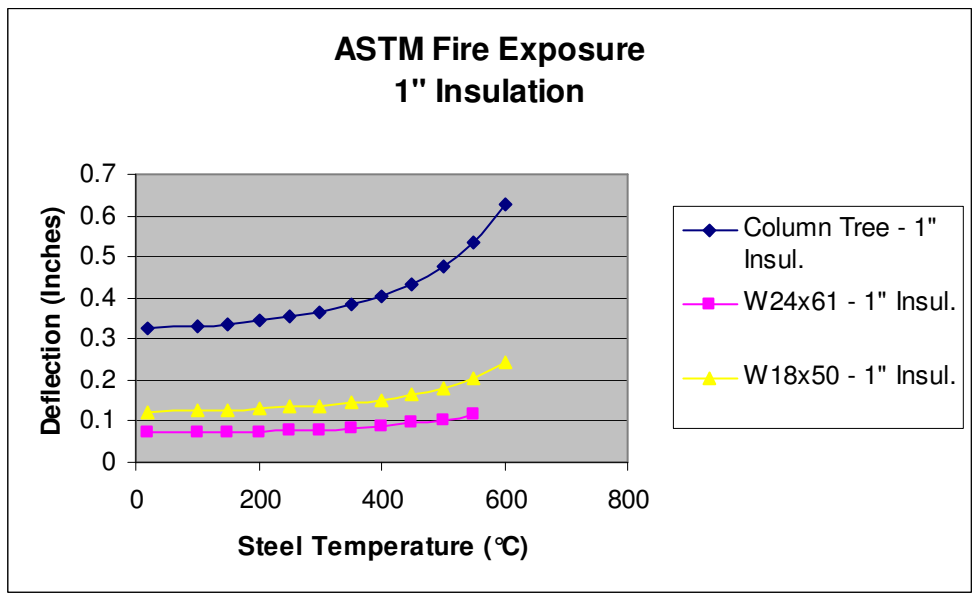
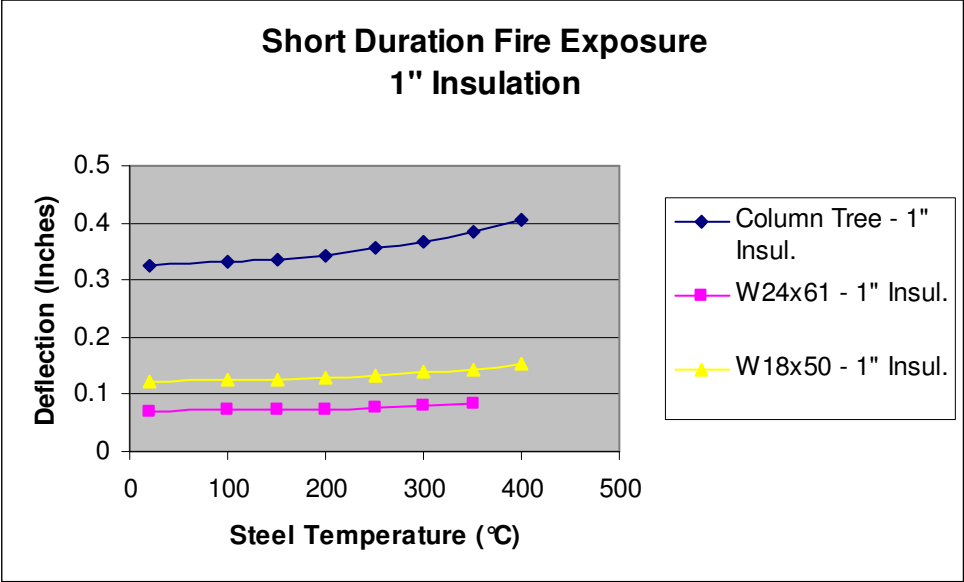
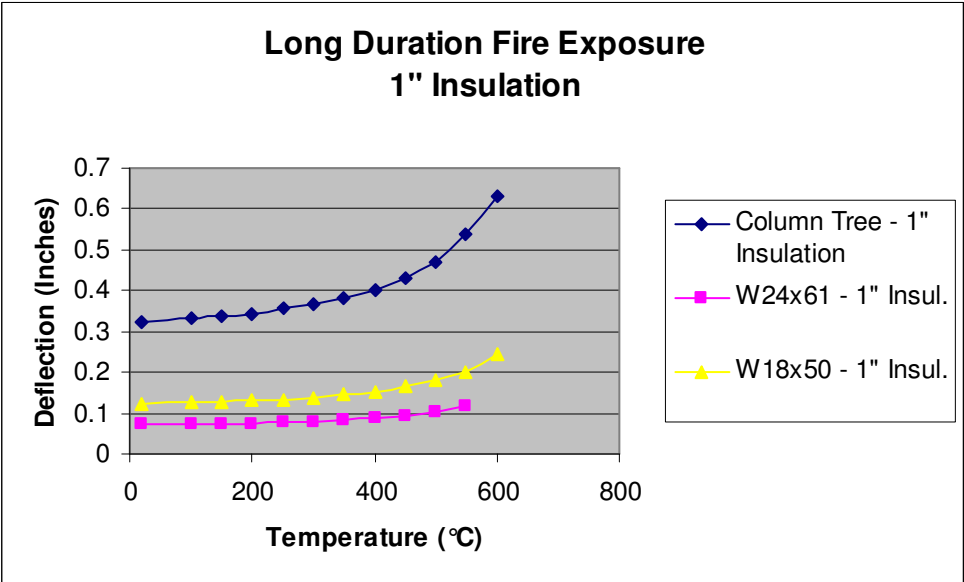
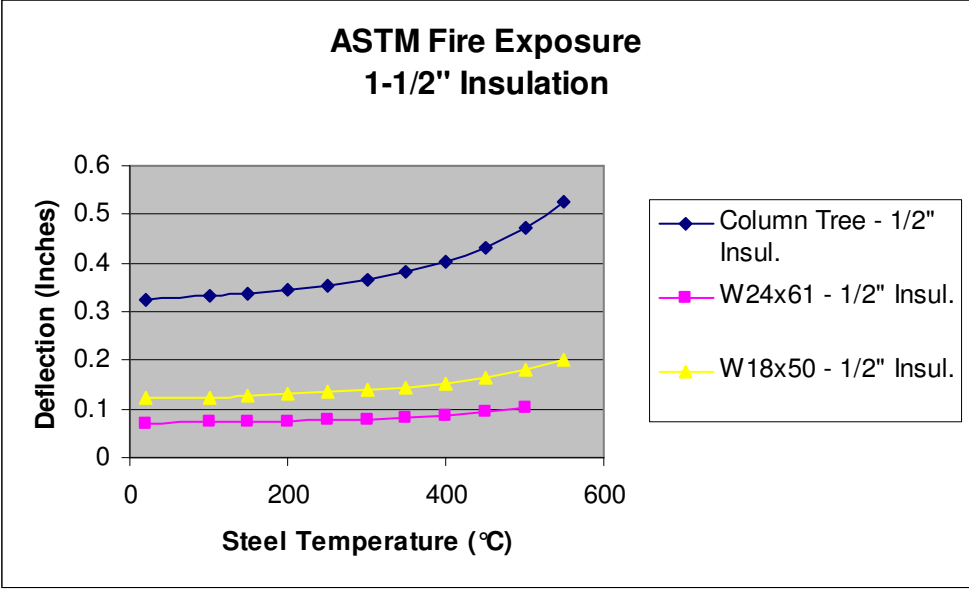
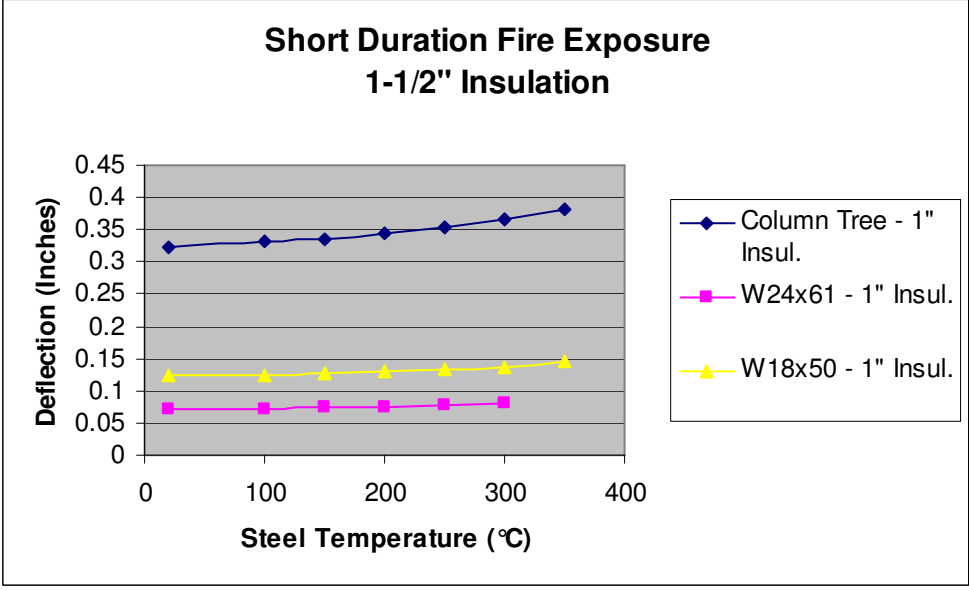
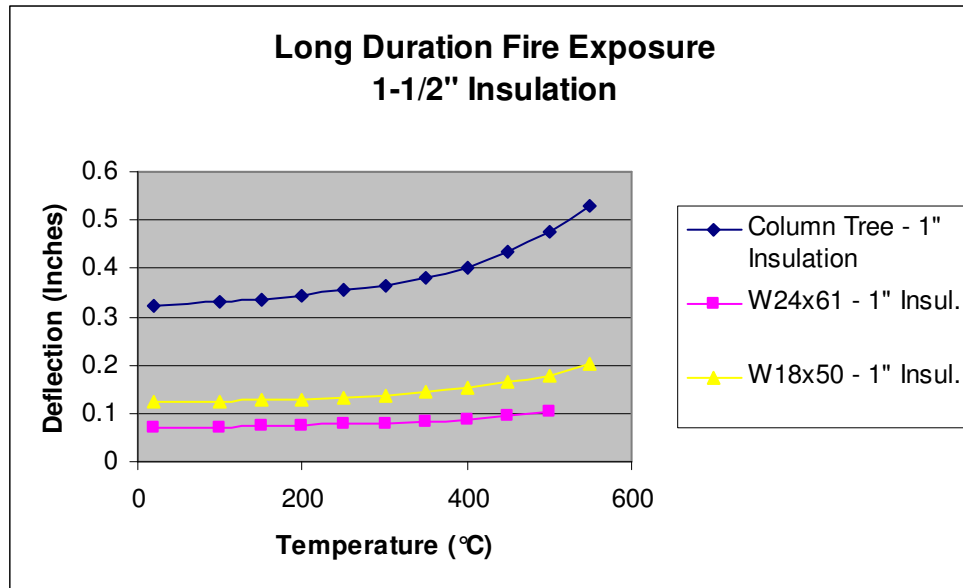
For all three insulation thicknesses, one can see that the behavior under the ASTM E-119 curve and the long duration fire are very similar. It can also be seen that as the insulation thickness becomes greater, the deflection drops. An interesting point to note from these graphs is the similarity in behavior of the deflection patterns, but the large difference in the amount of deflection between the continuous beams and the column tree assembly.

One should also note that the deflection limits of 0.73" (L/360) in the original case (L=22') and 1" (L/360) for the two continuous span alternative cases (L=30') is never exceeded under all three-fire conditions. This shows that all three framing systems could have theoretically handled the loads under the exposed fire temperatures so the system would not have failed due to deflection.

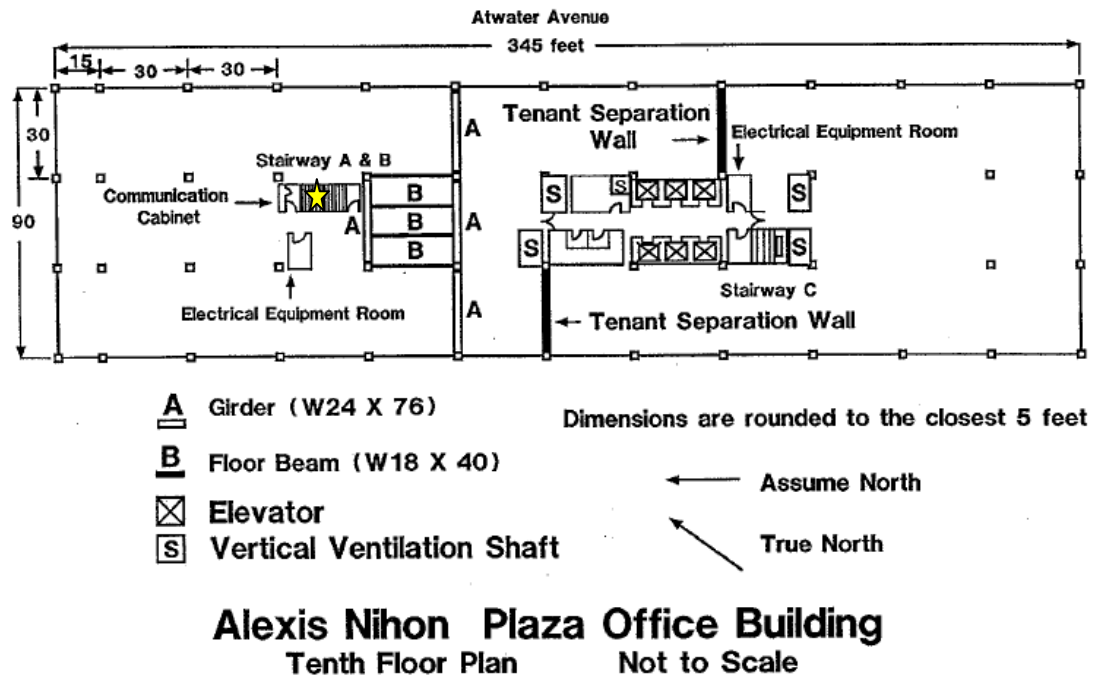
Figure 74 - Alexis Nihon Tenth Floor Layout

The building was constructed of a structural steel frame of 11 – 30 ft. by 30 ft. bays and 3 – 15 ft. by 30 ft. bays, as can be seen in Section 3.3, Figure 28. The girders (W24x76’s), beams (W18x40’s), columns and metal decking were all fire-protected with sprayed-on mineral fiber providing a 2 – 1/2 to 3 hour fire rating for the members. “The girder – to – column, beam – to – column, and beam – to – girder connections were made using double clip angles,” which were “welded to the beams and bolted to the columns or girders,” (Isner, 1986).

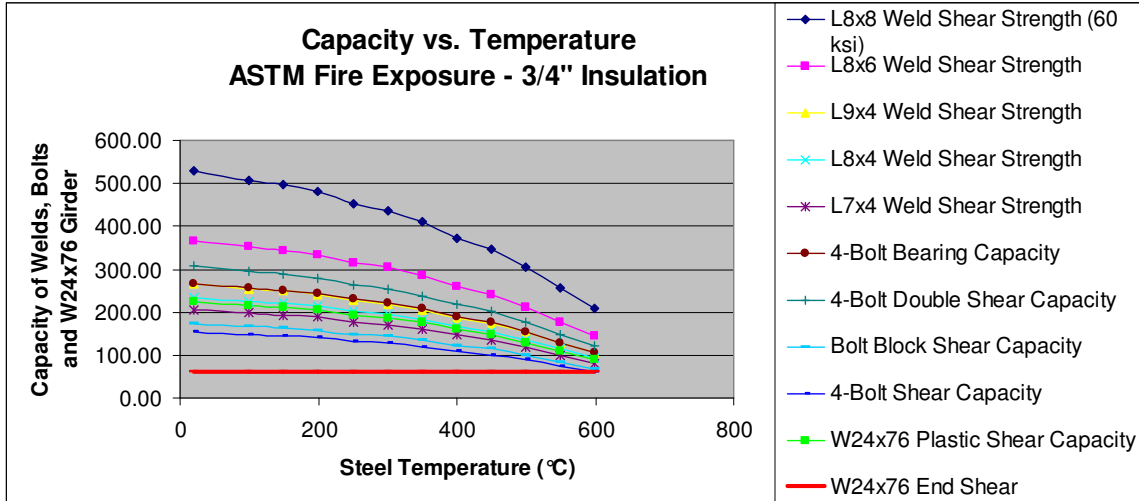
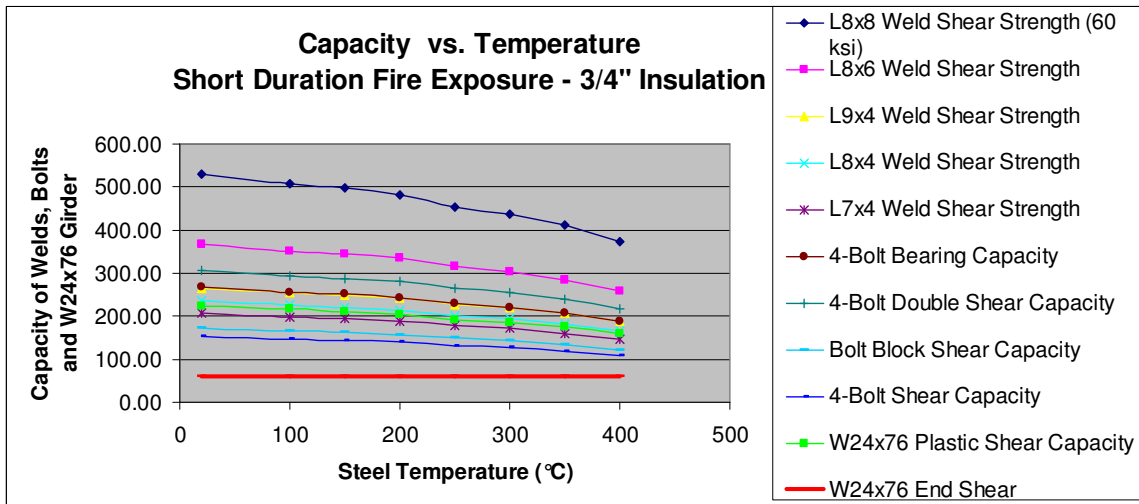
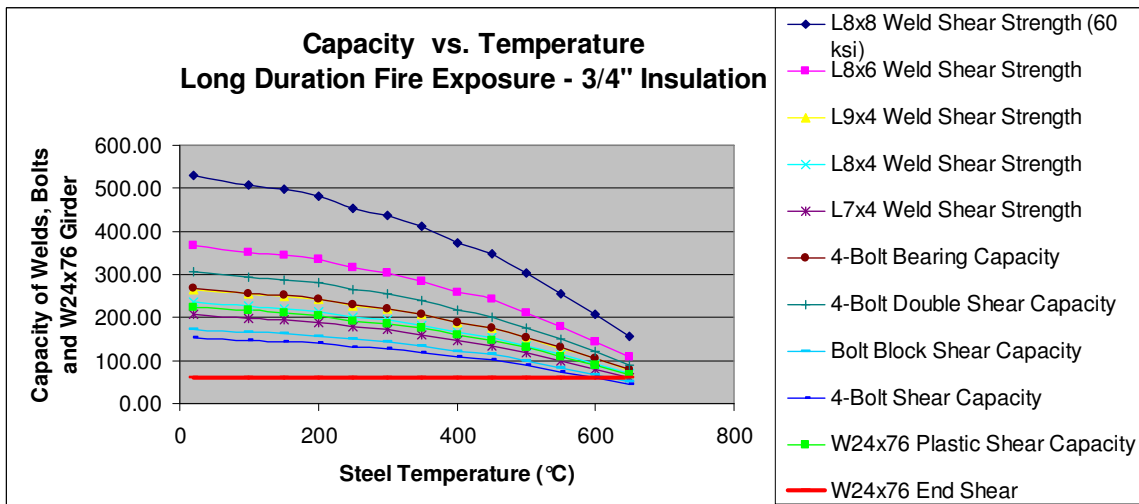
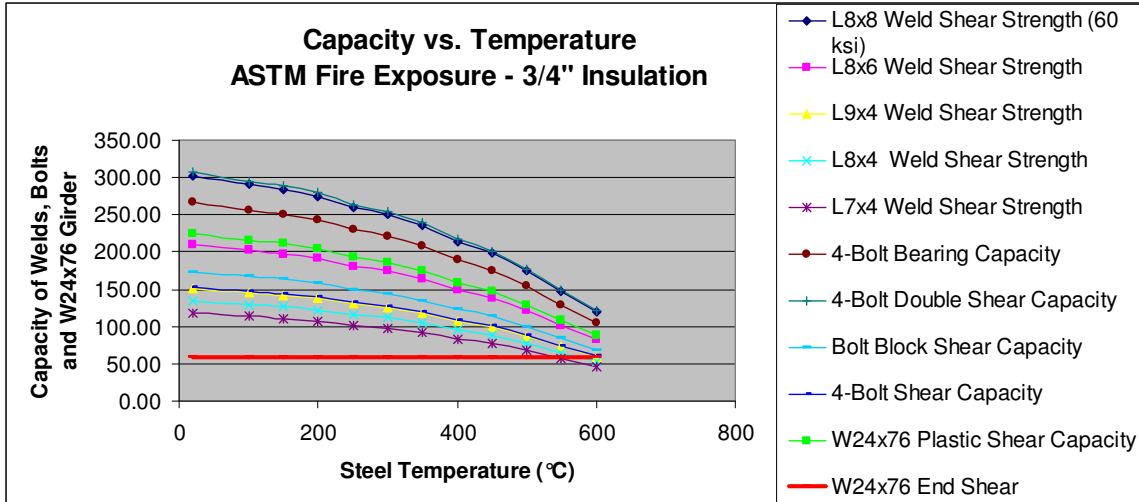
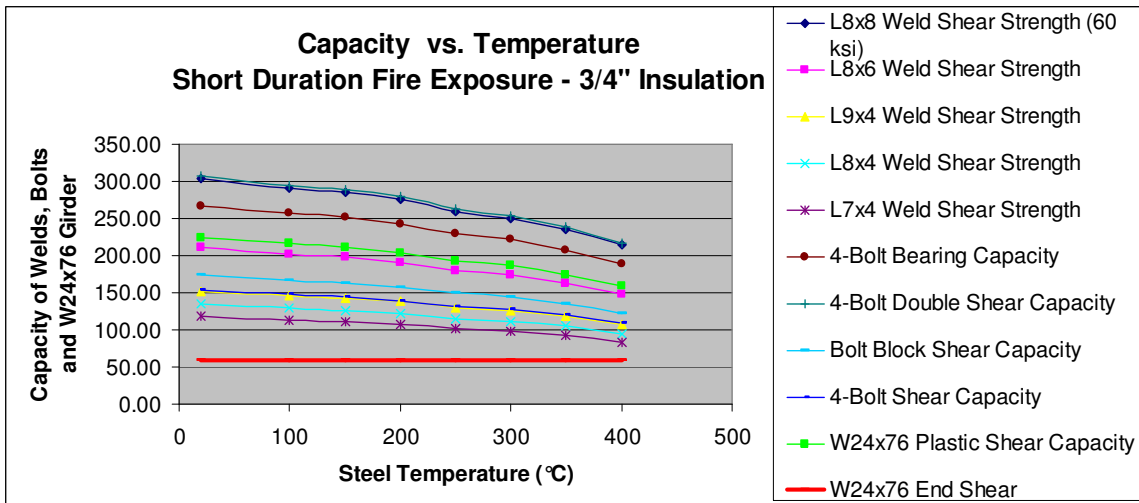
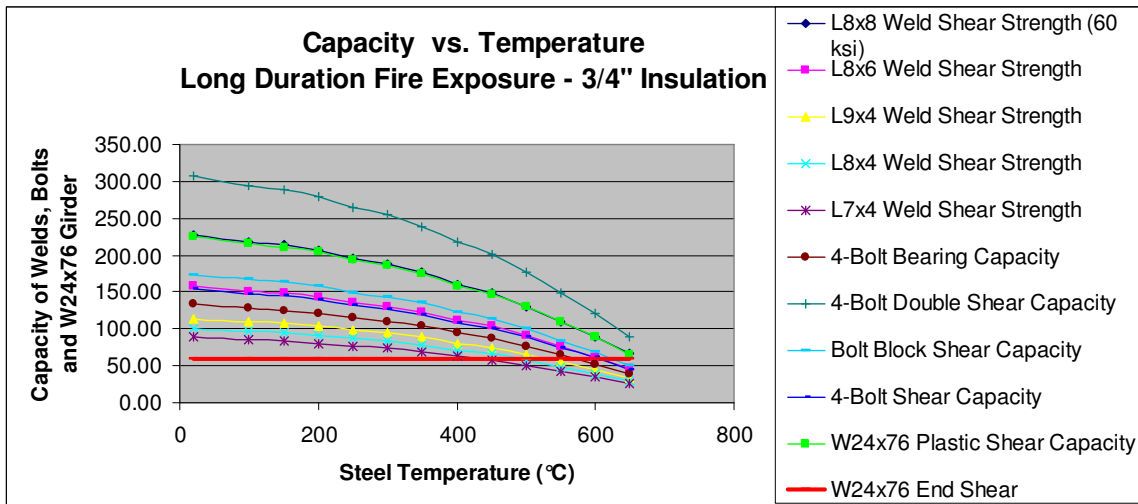
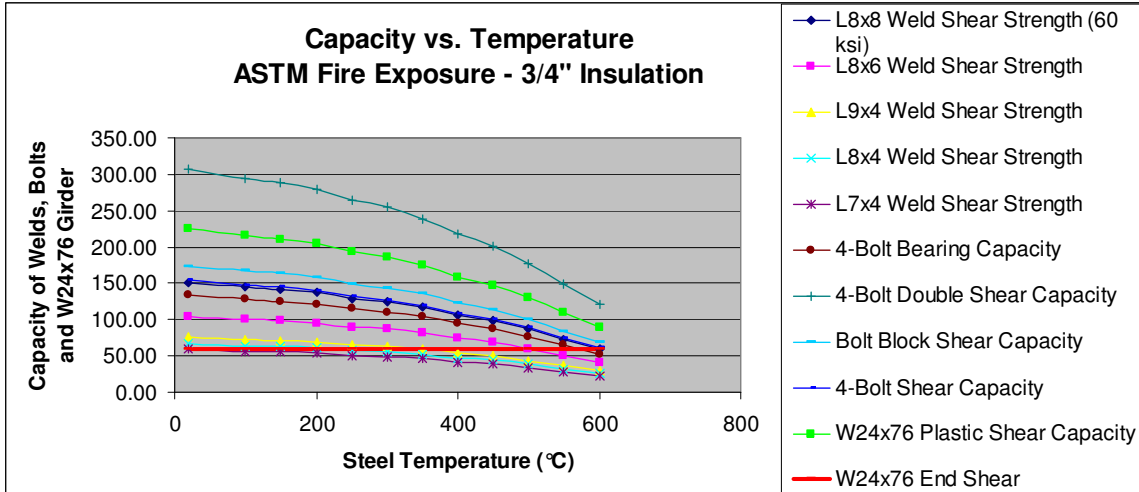
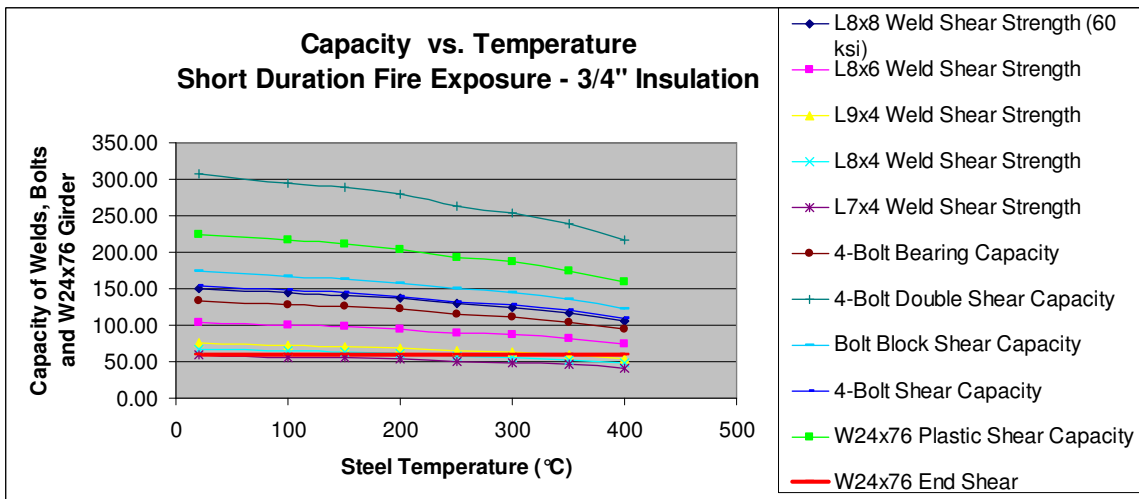
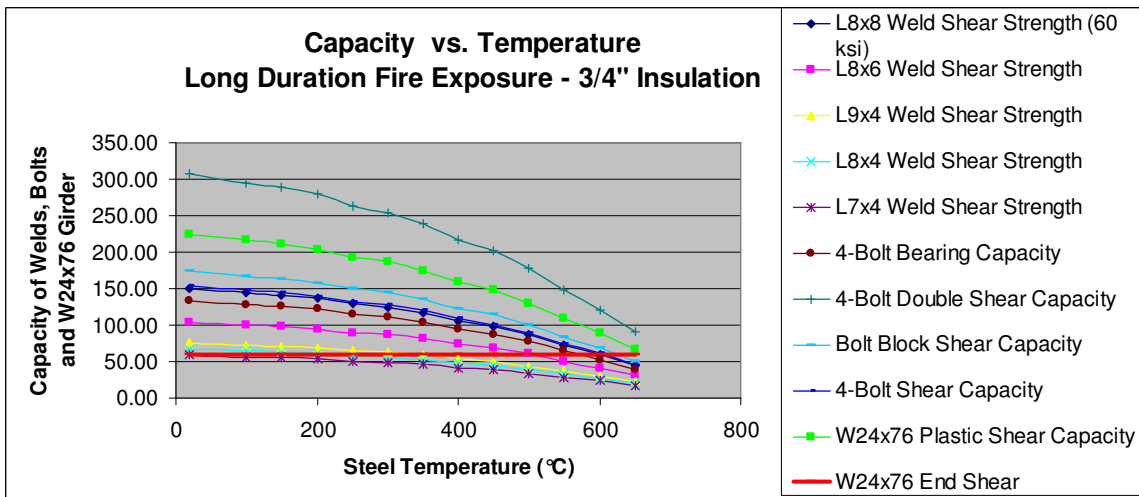
By looking at the twelve graphs above, the difference in strengths of variably sized $\frac{1}{2}$ " angles with $\frac{7}{16}$ " welds to variably sized $\frac{1}{4}$ " angles with $\frac{1}{8}$ " welds is obvious. Below are tables summarizing the modes of failure by temperature for each of the cases illustrated.

Under normal conditions, all of the angles and welds investigated were adequate but as temperatures increased due to the three simulated fires, it is apparent how long each weld would effectively last. It is an assumption that connections degrade at the same rate as the members they connect; however, as can be seen above, this is not the case since the plastic shear capacity of the beam never reached the yielding end-shear strength of 59.18 kips.
