Restoring Mrigadayavan Palace:

Understanding Causes of Concrete Deterioration and Determining Viable Concrete Rehabilitation Methods

The Mrigadayavan Palace
Foundation

C Term 2022

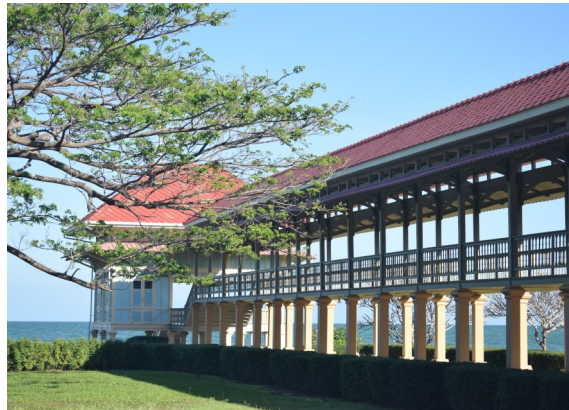
Figure 6. Mrigadayavan Palace corridor with ocean

In 2013, the Palace Foundation determined it was necessary to begin the current restoration. The Palace is situated in Thailand's southern region and is exposed to high humidity and rainfall.¹¹ Its location along the beach, as seen in *Figure 6*, results in weathering that causes damage to the structure more than the typical site location would. The Mrigadayavan Palace Foundation undertook this **current restoration project** with the goal of preservation and rehabilitation by the 100th anniversary of the Palace in 2024. Ideally, the Palace would be restored to its **original state** as it

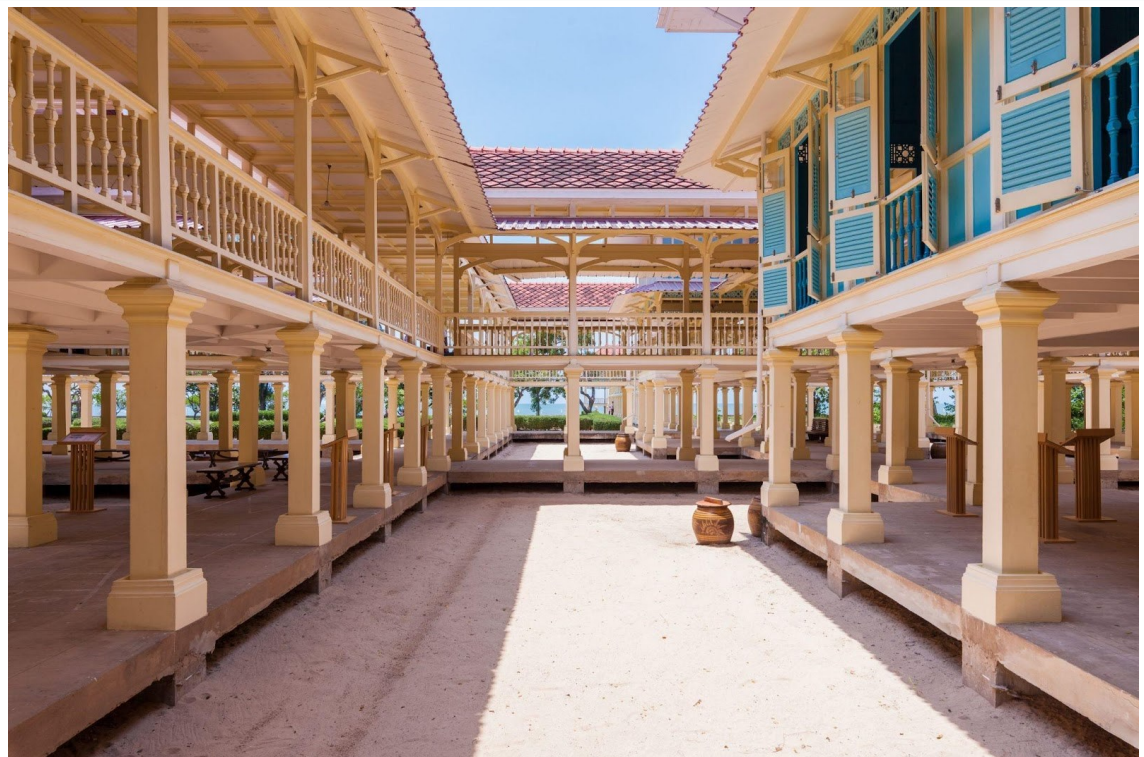
Figure 11. Photo of the Palace's Column Supported Walkways and Living Quarters¹⁸

There are a total of 831 concrete columns at the Palace, in which approximately 30% of these columns had small cracks. Approximately ten columns were severely corroded with major cracks in them. From the observations and the collected information, the possible factors that could affect the rate of corrosion and the most probable

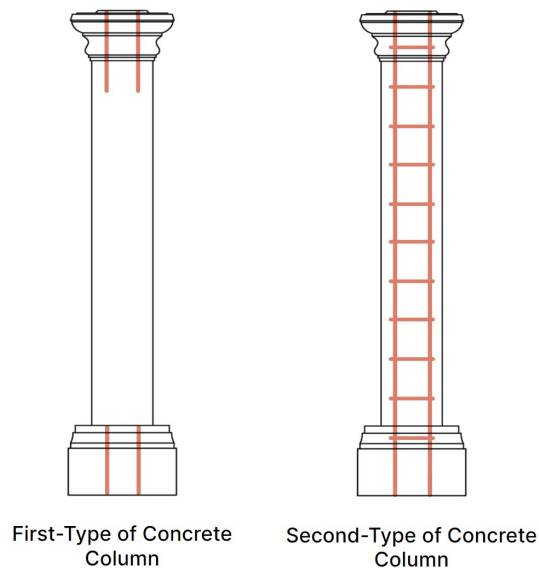
Figure 12. Illustration differentiating the first and second type of concrete columns

Palace. The first type is columns that have steel reinforcement only at the top and base of the column. The second type of column is columns that have steel reinforcement throughout the body of the column. The original type of concrete columns designed for the Palace by the original architect is the first type. However, later renovation efforts preferred the second type. An illustration differentiating the first type and second type of concrete columns can be seen in *Figure 12*.

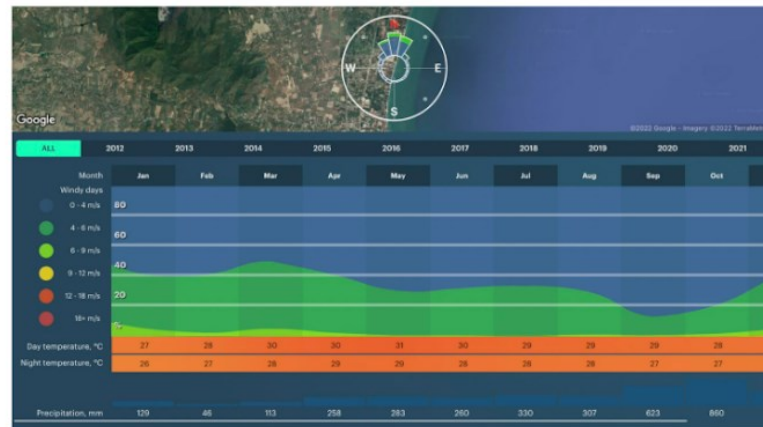
Figure 19. Detailed graph on direction and speed of wind

According to the “Windy” application, with the specific setting that is mentioned in the wind assessment section in objective one, the wind flows into the Palace from the shore majority of the time. An average from 2012-2021 showed that eight out of the twelve months of the year, the wind’s direction flows directly into the Palace from either the north or the south as seen in Figure 19. Only 4 of those months

showed that the wind flows in the opposite direction, which is away from the Palace. Another important finding is that the speed of the wind is also the strongest during those eight out of twelve months. Detailed graphs that contain the direction and speed of the wind with further detail can be found in *Supplementary Materials E*. This correlates with the observation that the horizontal cracks were found on the opposite side of the column that faces the shore because the prevailing winds would be able to add an additional lateral load on the concrete columns. Since the majority of the wind flows into the direction of the Palace from one side, the lateral load would be added on only one side of the Palace. Tension would be increased from only one side of the column and the other side of the column would experience a decrease of tension. The side that receives the increase in tension would be the side that forms the horizontal cracks.

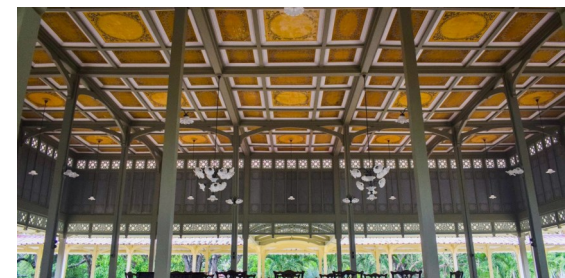
Figure 24. Photo of King's Dining Pavilion at the Mrigadayavan Palace

Other than the deterioration in the concrete walkways and columns, cracks and discoloration were also observed in the concrete ceiling panels. These concrete ceiling panels are found above every wooden walkway in the Palace. The panel placement in one area of the Palace can be seen in *Figure 24*.

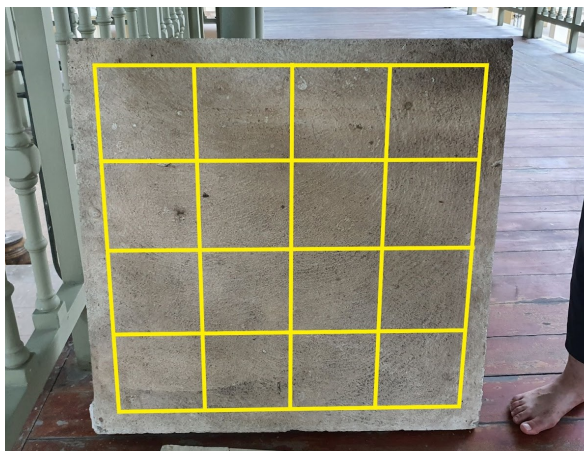
Figure 29. Steel reinforcement pattern in a ceiling panel

Aside from the cracks, another aspect that was affected was the discoloration. The concrete ceiling panel itself contained the inner steel reinforcement inside to support the structure. The **inner steel reinforcement** is a four-by-four metal bar block, which correlates with the pattern of discoloration on the panels. As shown in *Figure 28*, rust from the steel rods created a mark on the panels in a yellow-like color plus sign mark which correlated with the steel reinforcement pattern, in *Figure 29*, as observed by using the metal detector. Over time, humidity causes rust on the steel rods. Rust on the
