## **Storm Surge & Critical Infrastructure on Nantucket**

# **Storm Surge & Critical Infrastructure on Nantucket**

An Interactive Qualifying Project  
submitted to the Faculty of  
WORCESTER POLYTECHNIC INSTITUTE  
in partial fulfillment of the requirements for the  
degree of Bachelor of Science

Date:  
16 December 2015

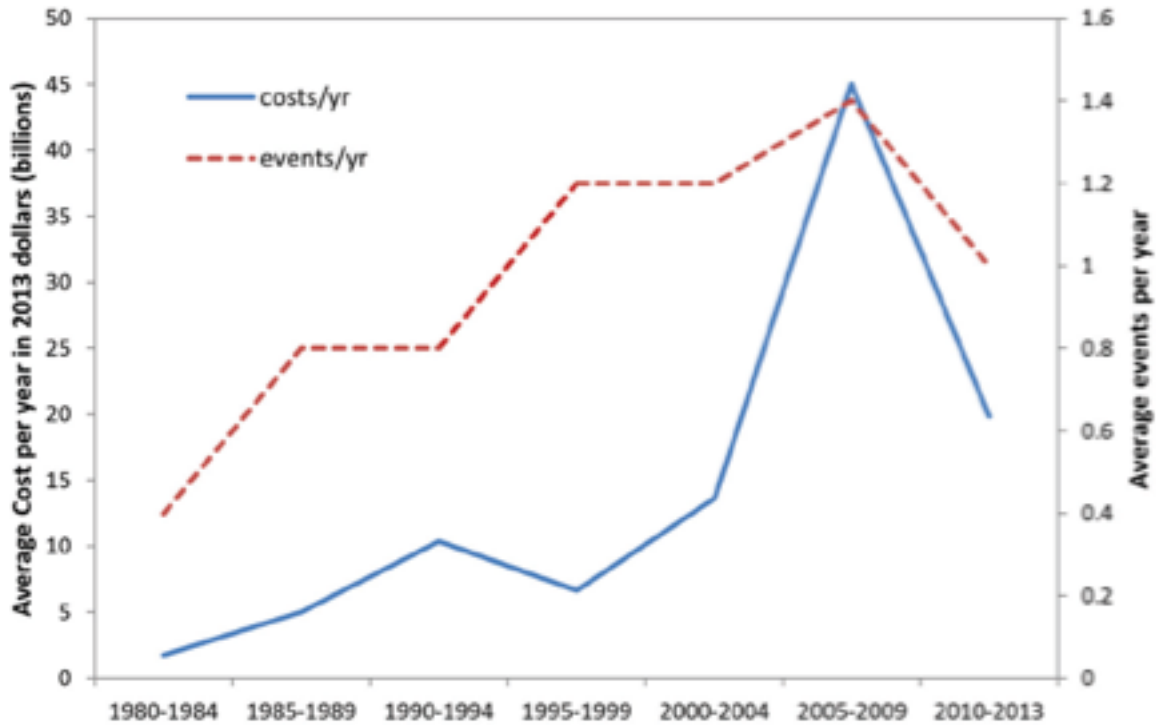
**Figure 1: Average Annual Cost of Coastal Storms in the United States**

Over the past 30 years, severe storms have struck the East Coast with increasing frequency. Figure 1 shows average costs associated with coastal storm events in the United States between 1980 and 2013, in 5-year increments (U.S. Army Corps of Engineers, et al., 2014). As you can see, the number of events and the costs associated with these events are increasing.

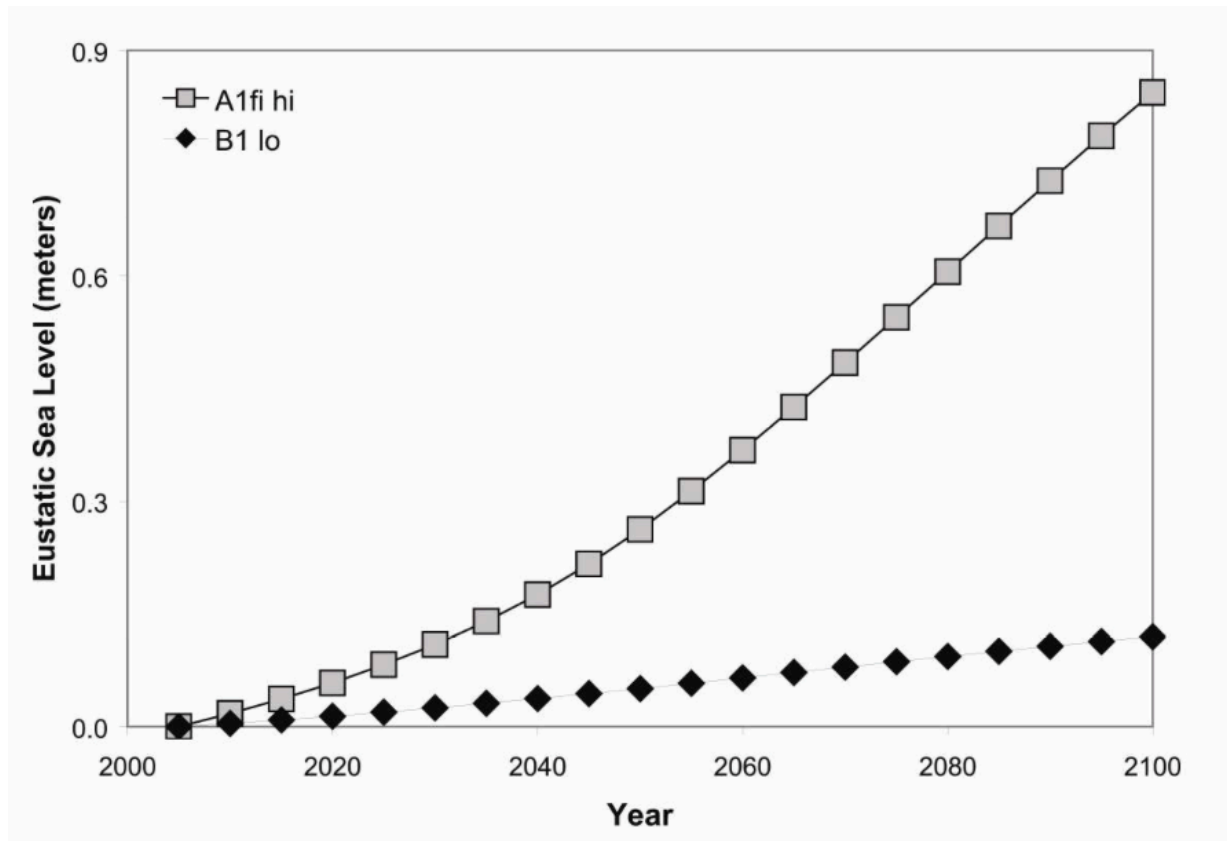
**Figure 2: Sea Level Predictions - A1fi hi & B1lo**

**The B1lo projection was created under a lower greenhouse gas emission scenario while the A1fi hi projection was made with a stronger consideration for the oceans absorbing more heat and ice sheets melting faster.**

Two different projections for sea level rise are displayed in Figure 2, from a study done by researchers from Tufts University and the University of Massachusetts (Kirshen, P., Watson, C., Douglas, E., Gontz, A., Lee, J., & Tian, Y. 2007).

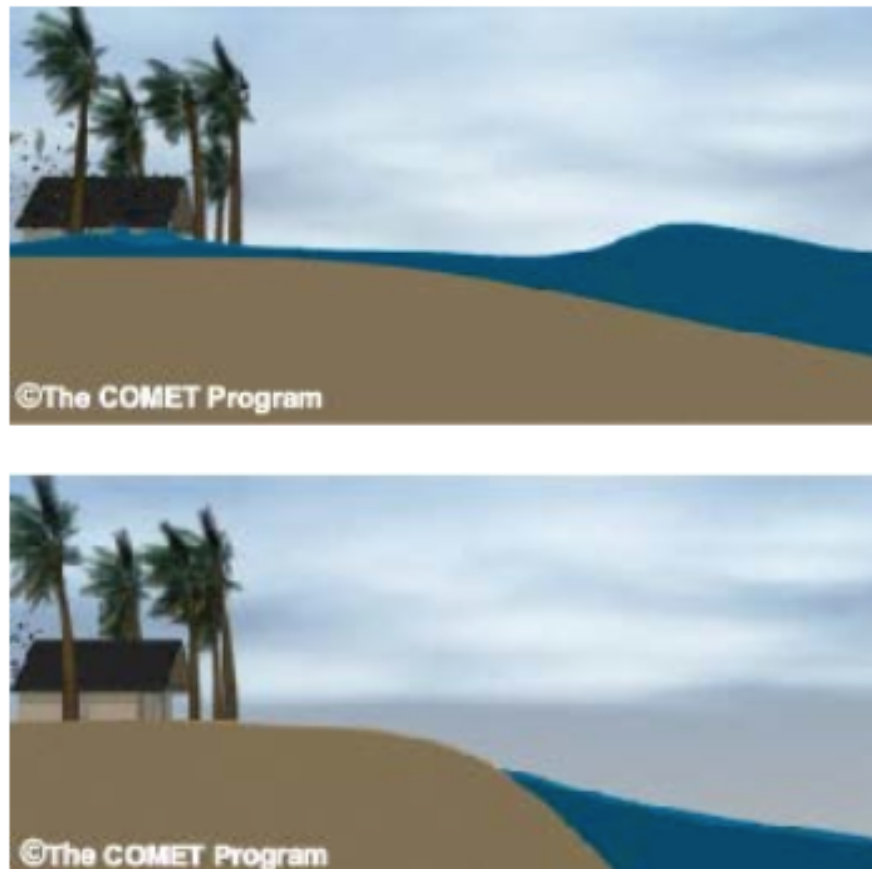
**Figure 5: The Effect of the Ocean Floor on Storm Surge**

**(Top): Example of a gently sloping ocean floor. (Bottom): Example of a steeply sloping ocean floor.**

Even the shape of the coastline can affect the storm surge; concave coastlines will typically experience a higher surge than convex coastlines. The topography of the ocean floor near the shore also determines the resultant storm surge; the surge is higher with a gently sloping ocean floor, as

opposed to a steeply sloping ocean floor (Figure 5). Finally, various other local features can affect the intensity of the storm surge. For downtown Nantucket, jetties and other natural barriers are examples of features that can protect land from direct impact from the open ocean (Introduction to Storm Surge).

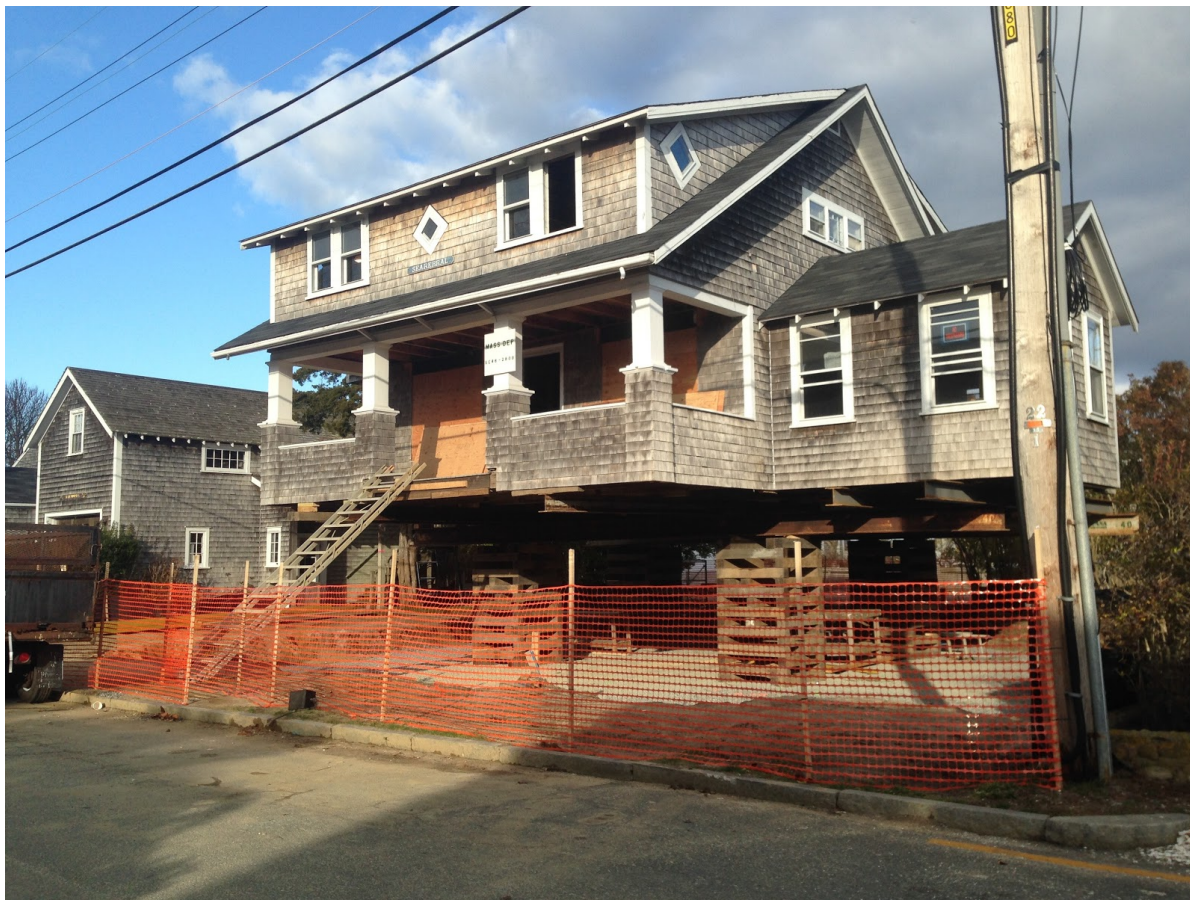
**Figure 7: House on Walsh Street, Sitting on Beams and Structural Supports**

Lastly, a building can be elevated onto support columns. Here, the building is raised on support beams; structural supports are placed underneath using columns, piers, posts, or pilings.

This approach is very common in coastal communities, as it allows for the greatest amount of water flow below the building (Homeowner's Guide to Retrofitting, 2014). Figure 7 shows an example of this type of elevation in Nantucket.

All of the above options serve to minimize the structure's contact with floodwater. In all cases, holes are left under the building, leaving space between the floor and ground levels. This allows for floodwater to flow through the building's foundation, reducing stresses on the structure caused by water pushing on its face (Homeowner's Guide to Retrofitting, 2014).

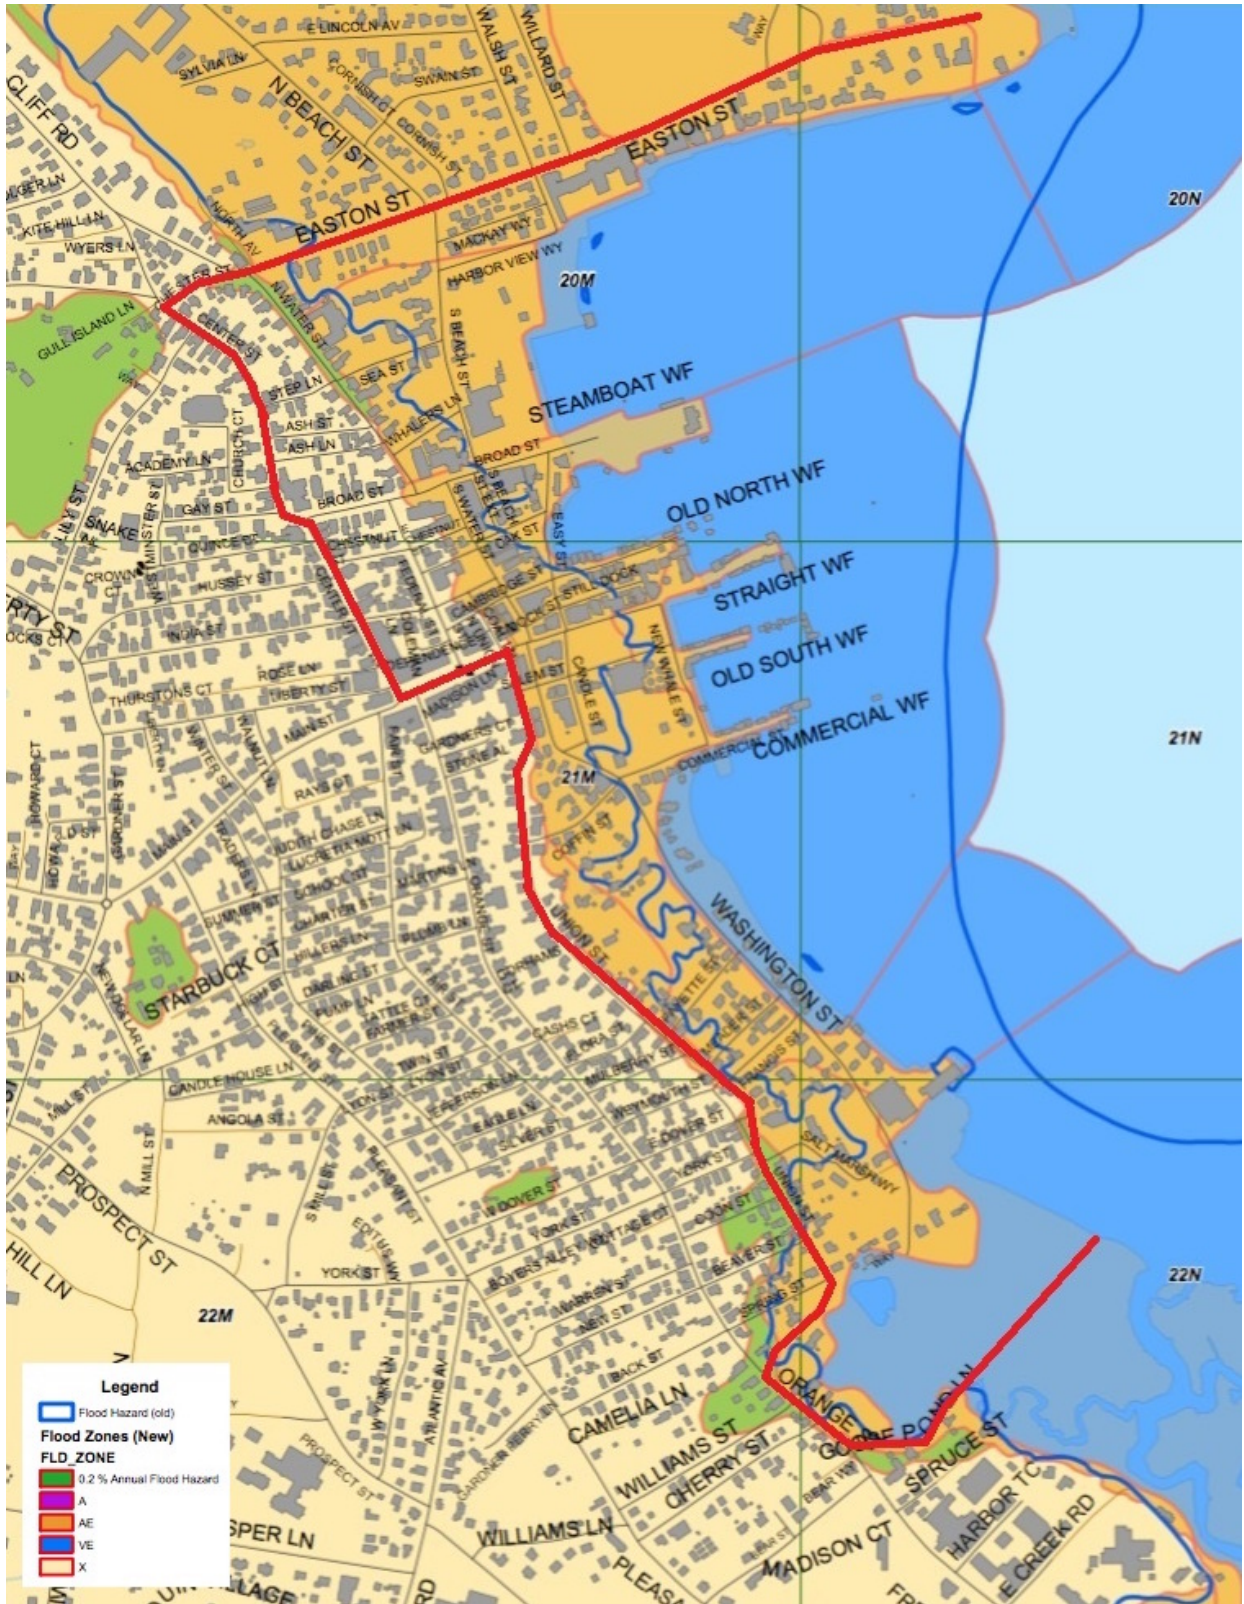
Figure 9: FEMA Flood Map with Boundary

In terms of emergency management, one of the greatest areas of local concern is the Island's downtown area, which is most prone to flooding and where critical infrastructure is situated. This includes Town offices, ferry terminals, fuel storage facilities, and key electrical and telecommunications infrastructure from the mainland. Figure 9 shows the 100-year and 500-year flood zones overlaid on the street network within our study area. The area of interest is bound by Easton Street and Chester Street to the north, Center Street, Main Street, and Union Street to the west, the Goose Pond Trail to the south, and Nantucket Harbor to the east. Almost the entirety of our area of interest is in this critical flood zone.

All of the waterfront properties on Washington and Easton Streets are in the 100-year flood zone and are prone to flooding. Some of these properties are even in the velocity zone—the area in the 100-year flood zone that can also be affected by storm-induced wave action (Zone V). This part of the town includes several government offices and other key buildings that are deemed critical.

To determine which items of critical infrastructure were located in the flood-prone areas of downtown Nantucket, we used the updated 2014 FEMA Flood Maps. By overlaying the flood maps on the baseline maps of infrastructure in Figure 9, we determined which pieces of infrastructure are situated in the velocity (VE) zone, the 100-year (AE) zone, and the 500-year zone (0.2%). In our checklists, we also included the FEMA flood map number for each piece of infrastructure, for ease of reference by users.

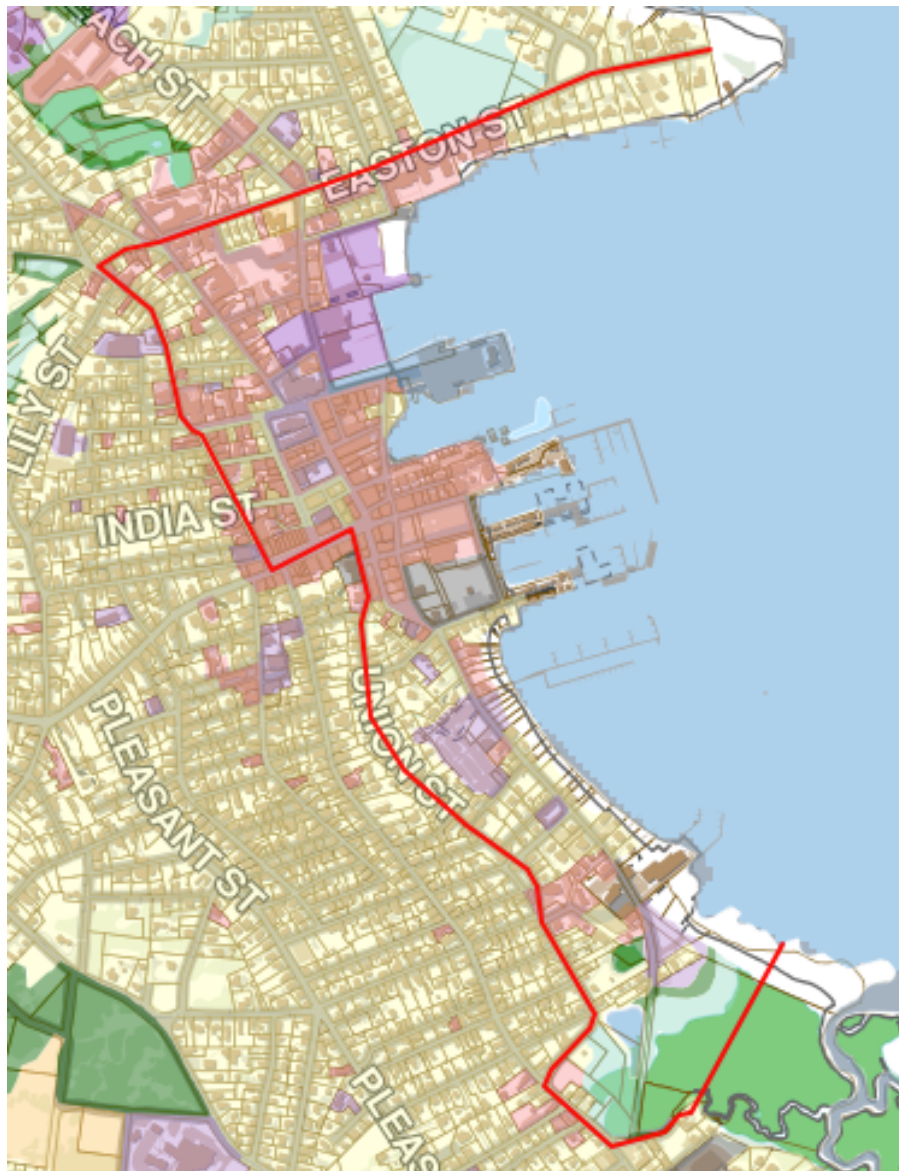
**Figure 10: GIS Map with Land Use**

The docks and transportation wharves in the blue area of Figure 10—which shows the mix of residential, commercial, and industrial usage in our boundary—are used for moving supplies, which is especially important before and after a major storm. Commercial areas include critical utilities and communications infrastructure. In the 500-year flood zone, effects of storm surge flooding extend even further inland to higher elevations and have the potential to put even more stress on buildings and infrastructure. This results in damage to an even larger number of commercial areas and public buildings, magnifying the effects of the storm, as even more pieces of infrastructure in the downtown will be damaged.
