Corridor Study of Route CT-156 in East Lyme, Connecticut

Project Report

A Major Qualifying Project Submitted to the Faculty of Worcester Polytechnic Institute in Partial Fulfillment of the requirements for the Bachelor of Science Degree

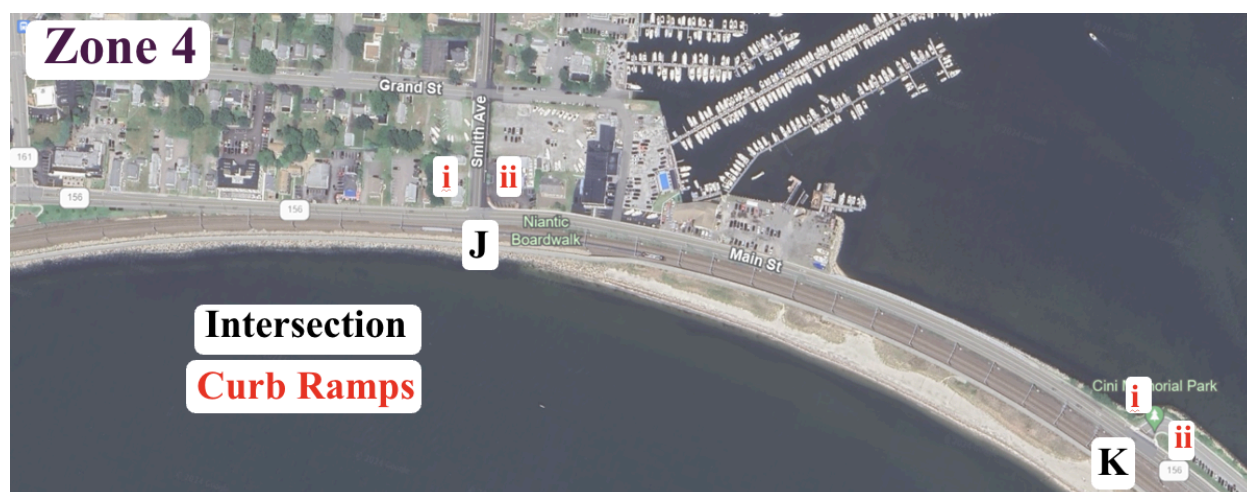
Figure 30: Google Earth view of Zone 4 with the intersections and the curb ramps labeled.

Table 6 is the last of the zones, Zone 4. There are two intersections associated with the zone and a total of four curb ramps. Figure 30 gives a view of the zone with the intersection and curb ramps labeled. No curb ramps are considered to be ADA-compliant. Only Intersection J Curb Ramp i and ii were labeled as “Good” condition. Three out of the four curb ramps have reasons listed in the table as to why they are non-compliant. Intersection J Curb Ramp i is the only curb ramp to have no detectable warning mat present while Intersection K Curb Ramp i is the only curb ramp that has an obstruction. The two curb ramps from Intersection J have no landing area as well, one with a turning space obstruction. Intersection K is the only recorded intersection to have water ponding.

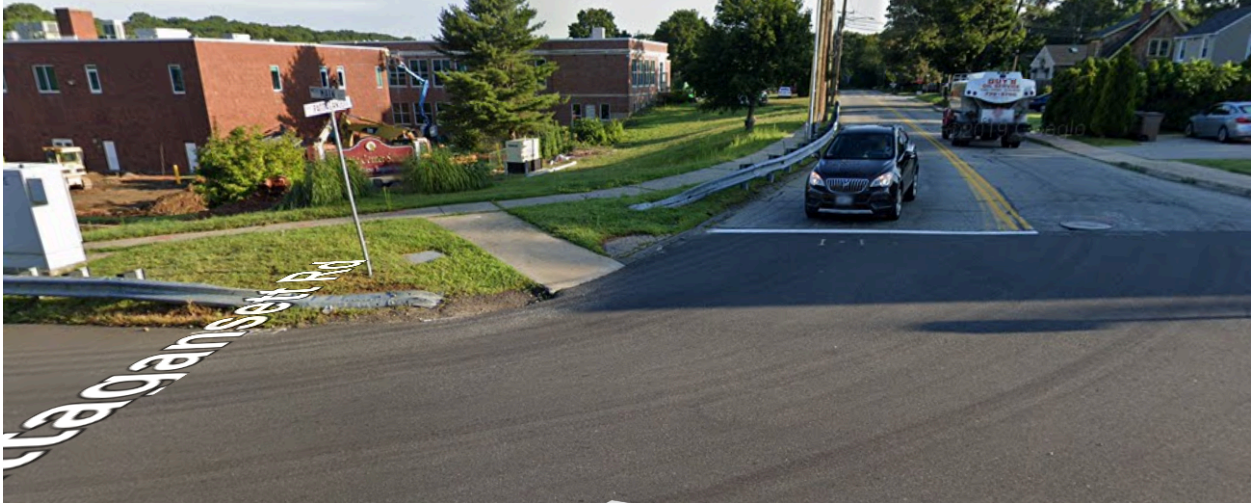
Figure 42: Google Earth view of Existing Condition of Curb Ramp i at Intersection A.

This zone contained a total of 8 curb ramps with only one compliant ramp in the zone. The first curb ramp, Curb Ramp i in Intersection A, is located in a four-way intersection. The curb ramp is coming from the corner of the elementary school. The existing curb ramp can be seen in Figure 42. The curb ramp lacks a detectable warning strip and a proper landing area. However, adding those changes will make the curb ramp compliant. Adding an additional crosswalk to the south side of the street, instead of only the east side, would allow safer options for pedestrians crossing the road. Figure 43 shows the proposed redesign of the curb ramp. The detectable warning strip and landing area have been added along with a more curved edge for pedestrians going either to the east or south.

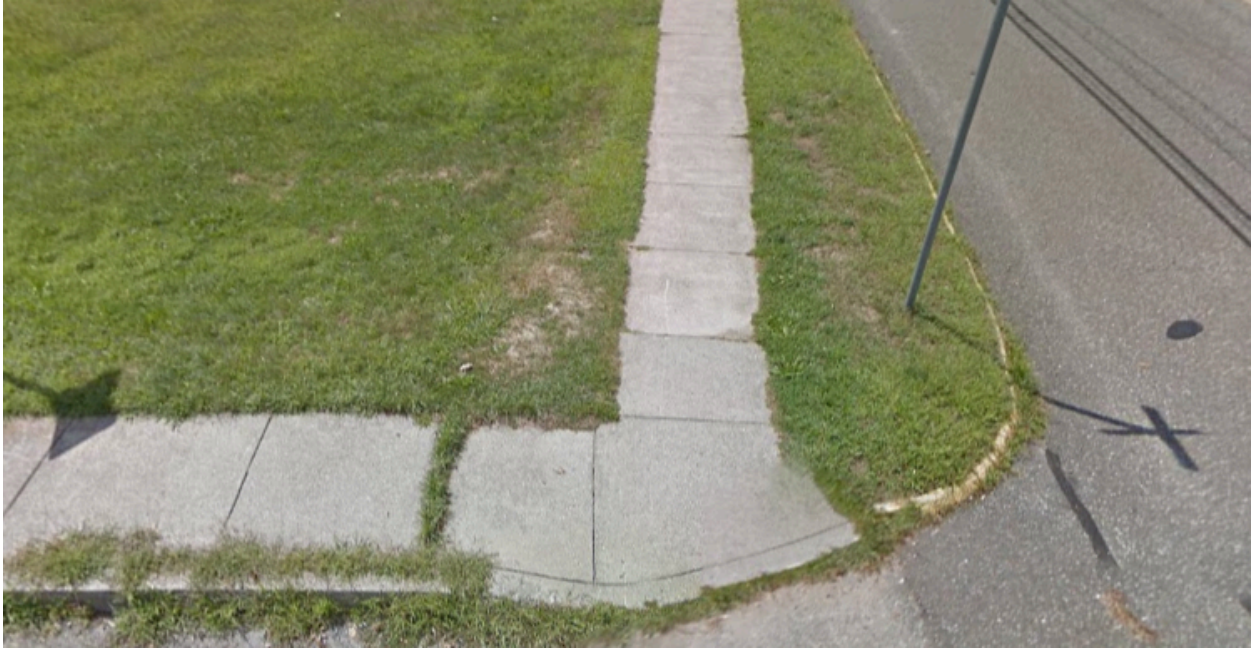
Figure 44: Google Earth view of Curb Ramp i at Intersection D in Zone 2

The curb ramp i, in Figure 44 and 45 is located on Intersection D Zone 2 was featured because there were many problem areas associated with this particular curb ramp. There is no Detectable Warning Mat at this curb ramp intersection. The crack also exceeds $\frac{1}{4}$ inch vertical gap at the landing area. The landing turning space cross slope and running slope both exceed the maximum requirements. Recommendations for this curb ramp will be to adjust the running and cross slopes so they are within the maximum 8.33% and 2% slopes per ADA requirements. Adding a detectable warning mat and leveling the curb ramp so the crack does not exceed $\frac{1}{4}$ inches at the landing area will transform this curb ramp to ADA standards.

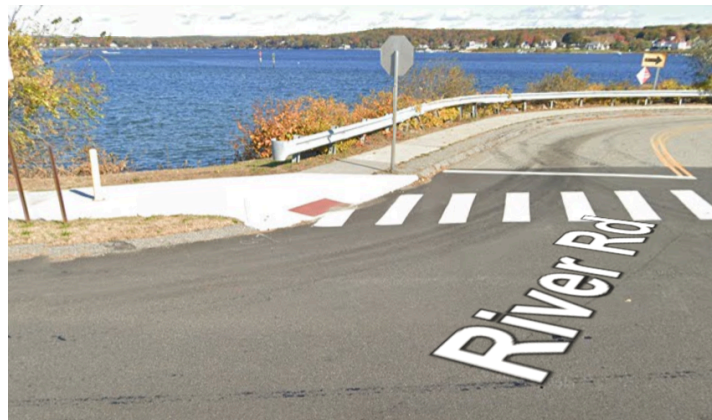
Figure 48: Proposed Google Earth view of Curb Ramp i at Intersection K in Zone 4.

This curb ramp had only three problem areas, however, they are from different categories which is why this curb ramp was chosen. The right flare slope exceeded the maximum requirement of 8.33% and there is water ponding at the opening of the curb. Similar to the previous curb ramp addressed in Zone 3, the recommendation would be to raise the structure of the curb ramp so there is no possibility for water to pool at the base. Reconstruct the right flare slope so it is 8.33% slope maximum.
