# ACCESSIBLE PEDESTRIAN SIGNALS

## *EVALUATING PEDESTRIAN SIGNALS FOR VISUALLY IMPAIRED PERSONS IN COPENHAGEN*

An Interactive Qualifying Project submitted to the faculty of Worcester Polytechnic Institute in partial fulfillment of the requirements for the Degree of Bachelor of Science

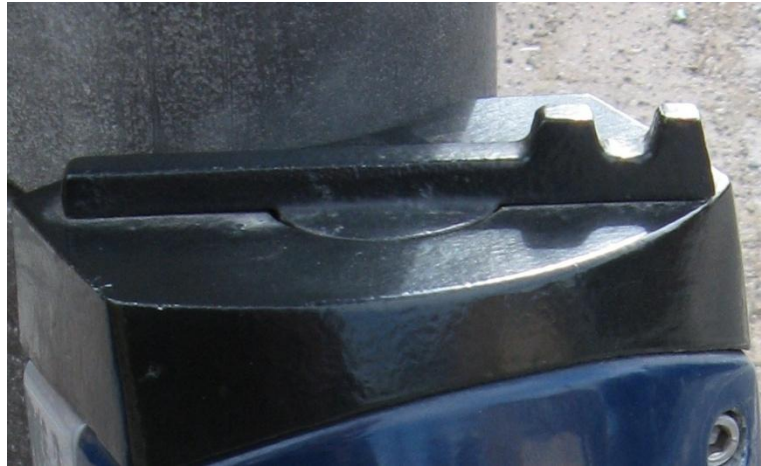
**Figure 4: Tactile arrow in Copenhagen**

This figure shows a tactile arrow mounted on an APS device in Copenhagen. It has two bumps, the outer bump indicating the direction of travel and the inner bump indicating that at least one median is present (Vejdirektoratet, 2006). This particular picture shows an older APS device that is being replaced with newer ones (Bjerremose, Frederiksen, & Kreutzfeldt, personal communication April 7, 2010), although arrows on newer devices function the same way. The standard dimensions of these arrows are shown in Figure 5.

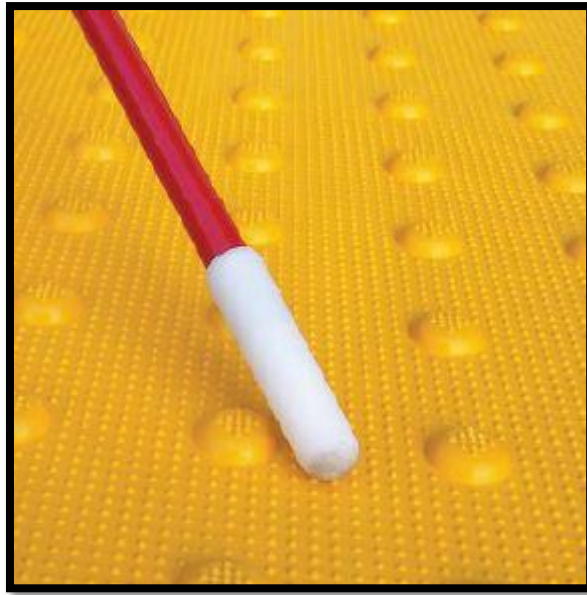
Detectable Warning Surfaces (DWS) are used to indicate that a pedestrian needs to stop and assess their surroundings. The United States Access Board defines DWS as “a distinctive surface pattern of domes detectable by cane or underfoot... used to alert people with vision impairments of their approach to streets and hazardous drop-offs” (United States Access Board, 2008). All DWS are designed to act as stop signs, where the pedestrian must determine that it is safe to continue before they do so. US guidelines for manufacturing specify a truncated dome shape as shown in Figure 7 (United States Access Board 2008). The color must contrast with the surrounding environment; the DWS shown in the photo is bright yellow. This color contrast is helpful for people who are partially sighted as well as guide dogs (Dansk Blindesamfund, personal communication, April 14, 2010).

**Figure 7: White cane on DWS (ADA Solutions, Inc.)**

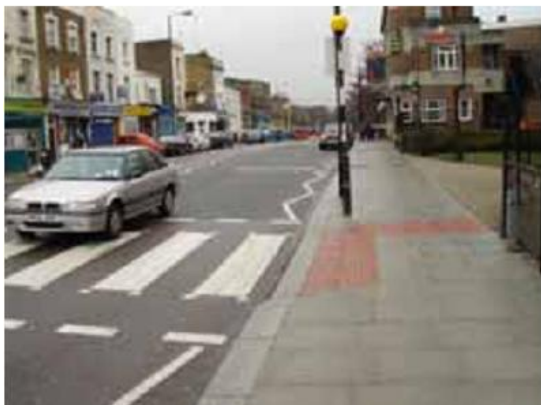
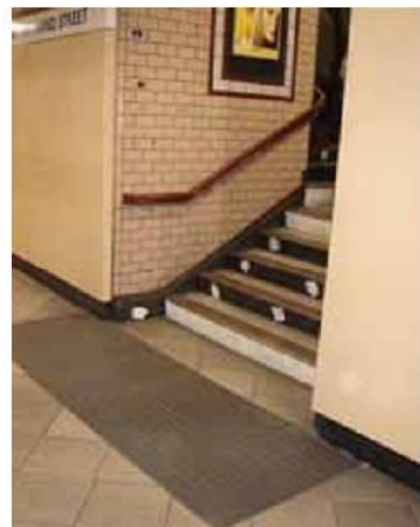
DWS are applied in a number of distinct ways. They are often used at curb cuts to ensure the edge of the sidewalk can be detected. They are also common at train platforms worldwide, though the type of DWS varies by country (Katsumi, Tomomi, Arisa, Kunijiro, and Mayumi 2008). The Copenhagen S-Train uses raised domes that also indicate the safe distance for sighted persons to stand from the platform. Another strategy is to place DWS in an L-shaped configuration to indicate that an intersection is present, and warn pedestrians of the curb cut. A London example of this is shown in Figure 8, on the left. On the right is an example of DWS at the bottom of a staircase, also in London, UK, used to reduce the risk of stairway-related accidents (Katsumi et al., 2008).

**Figure 8: Applications of DWS in the UK (Katsumi et al., 2008)**

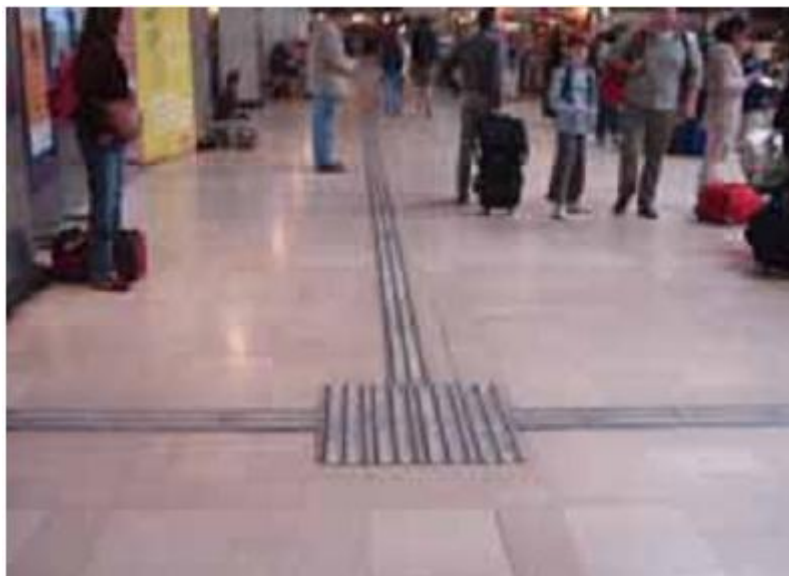
A different form of TGS is used for helping pedestrians with visual impairments navigate to their destination. Directional blocks constitute tactile paths designed to lead pedestrians to their destinations. Figure 9 shows a tactile path installed on an experimental basis at the Montparnasse train station in Paris, France. It consists of gray metal directional blocks with three parallel ridges arranged in a T arrangement. Four of these directional blocks are combined into a square to indicate the junction of two pathways. One pathway connects the platform with the main door to the station, while another runs parallel to the platform.

**Figure 9: Directional blocks forming tactile path in France (Katsumi et al., 2008 9)**

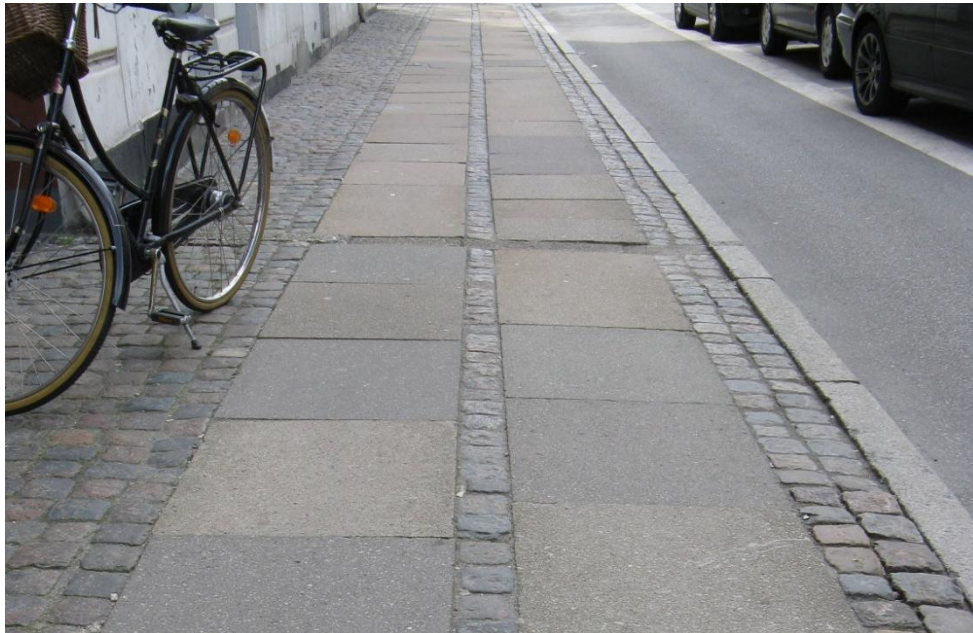
many sidewalks. Cobblestones and concrete slabs are alternated so that the cobblestones provide a tactile path along the entire sidewalk. In many cases, this path leads down the middle of the sidewalk. Figure 10, a picture of a sidewalk in Copenhagen, Denmark taken by one of the authors, shows this form of tactile pathway.

**Figure 10: Sidewalk with tactile cobblestone path in Copenhagen**

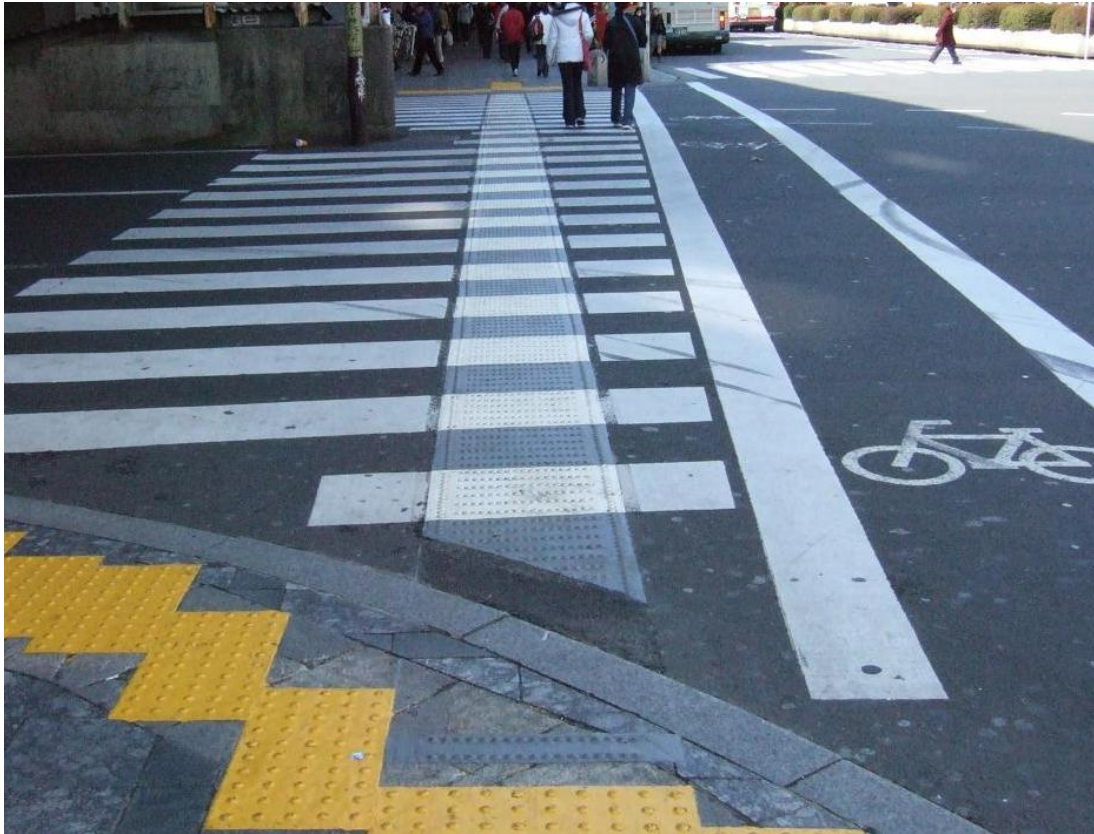
Some countries, predominantly in Asia, use tactile paths to help pedestrians cross the street without veering from the crosswalk. Figure 11, below, shows a Japanese crosswalk where a tactile path directs pedestrians from the DWS on one side of the crosswalk to the other. The DWS is yellow and roughly follows the curve of the street corner; the tactile path is white and straight. The crosswalk is indicated by white lines perpendicular to the tactile path while a bicycle lane to the right uses lines parallel to the path. Truncated domes are used for both DWS and directional blocks though the size and spacing is different.

**Figure 11: Tactile path crossing a street in Japan (“Tactile Guiding Line”, 2006)**

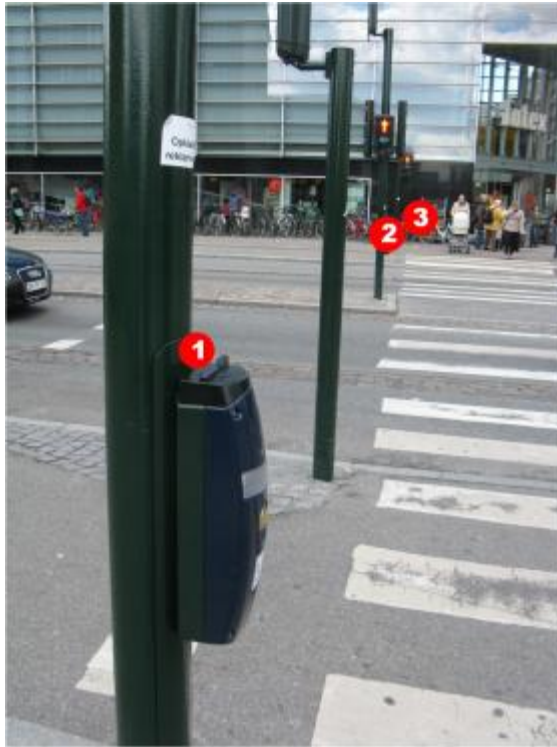
Other Danish standards include having islands of no less than two meters long as well as all APS devices being on the same side of the crosswalk, as can be seen in Figure 17. This is done so pinpointing the direction the signal is coming from is easier. Danish APS standards also require that APS devices emit a beeping sound as opposed to the knocking or hammering sound, which is used in Sweden. Despite this, the most recent installation of APS devices in Frederiksberg makes use of the knocking sound (Dansk Blindesamfund, personal communication, 2010). This was done to reduce complaints about the system being on all hours of the day.

**Figure 17: All APS devices are along the same side of the crosswalk.**

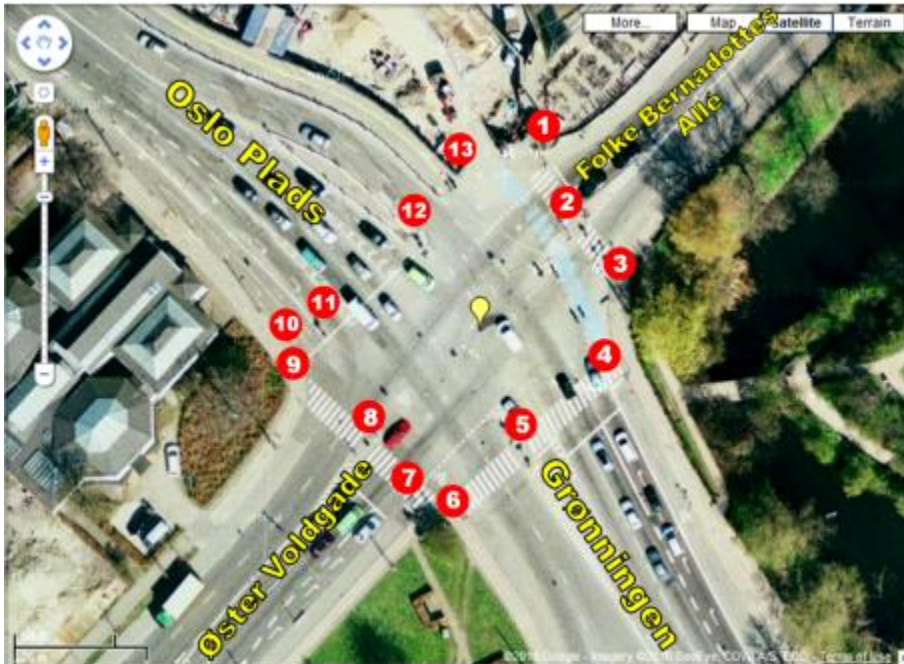
Figure 18: An overview of the Folke Bernadottes Alle and Oslo Plads intersection (Google Maps, 2010)

The first intersection we investigated was that of Folke Bernadottes Allé and Oslo Plads. This intersection was by the Østerport train station, which we took note of as the sound of trains coming and going could affect audibility of the signals. We also took note of the near-90 degree angle of this intersection. In Figure 18 below, we used the Google satellite overhead image to show the complexity of this intersection. We also labeled and numbered the locations of each APS device in the intersection so they can be referred to for this discussion.

This intersection was selected for multiple reasons. We had formulated a checklist for analyzing intersections and needed to test it. We chose to do so with this intersection because it was fairly large, with multiple car lanes and bicycle lanes as well as traffic islands for each road, with Oslo Plads having two islands. We noticed that every corner and island was outfitted with APS devices, which emit signals that we have heard walking to and from Østerport station. This intersection can be considered a problem intersection, because during this test of our methodology we noticed that three of the APS devices present were nonfunctional.

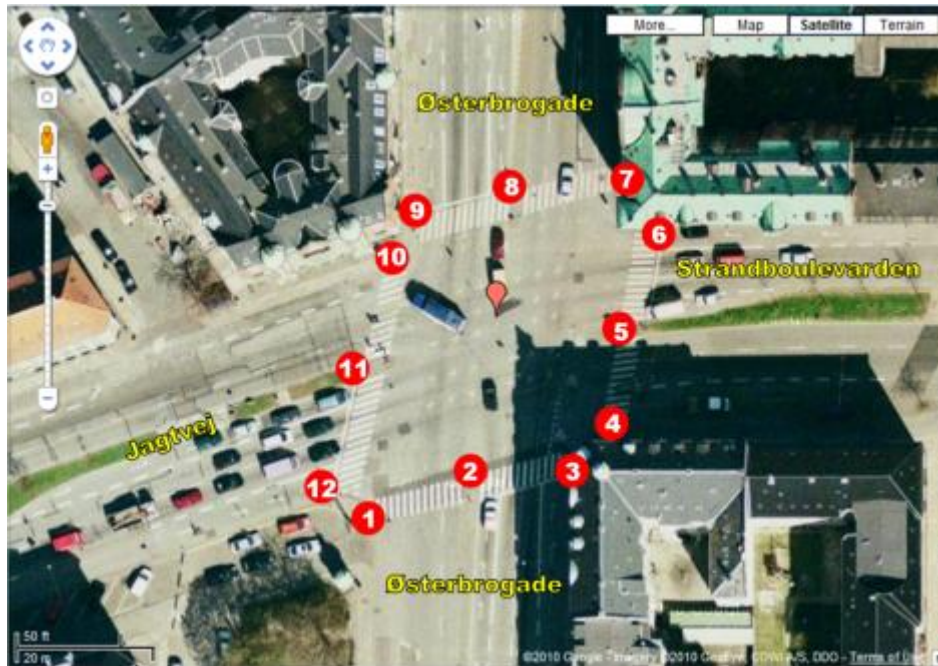
Figure 19: An overview of the Østerbrogade and Jagtvej intersection (Google Maps, 2010)

The second intersection we surveyed was that of Jagtvej and Østerbrogade. This was in a neighborhood that was part residential and part commercial. We again labeled and numbered a Google satellite overhead image to show the location of the APS devices in the intersection.

We were told about this intersection by Mr. Niels Peter Bjerremose, one of the traffic engineers. He mentioned that older model APS devices were installed there. There were twelve APS devices manufactured and installed by Swarco present, two on every corner and one on every island, as shown in Figure 19. In this system, a small microphone is used to pick up background noise. Doing so would then trigger the system to raise the volume of the signal. The problem with this was that it would mistake signals from other devices in the intersection for background noise and thus, the volume would increase unnecessarily. Because this area is partly residential, this proved to be a great nuisance especially at night. Fixing this problem required removing the lid and then adjusting the potentiometers for both the microphone and the speakers with a screwdriver (Bjerremose, Frederiksen and Kreutzfeldt 2010).

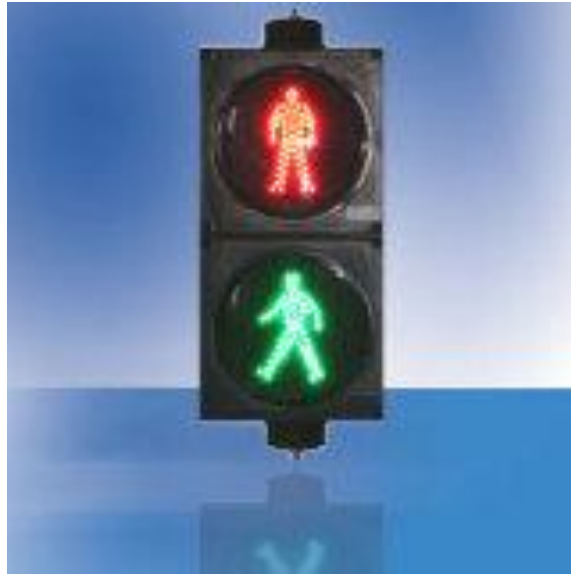
Most signaled intersections in Copenhagen are equipped with pedestrian walk indicators. These consist of a standing “red man” located directly above a walking “green man” such as in Figure 20 below, although women are sometimes shown to add variety. The presence of two red light signals also does not change its meaning. This is done mostly to catch the attention of pedestrians waiting to cross at streets with multiple lanes and traffic islands while providing a backup light bulb.

Figure 20: Pedestrian Walk Indicator

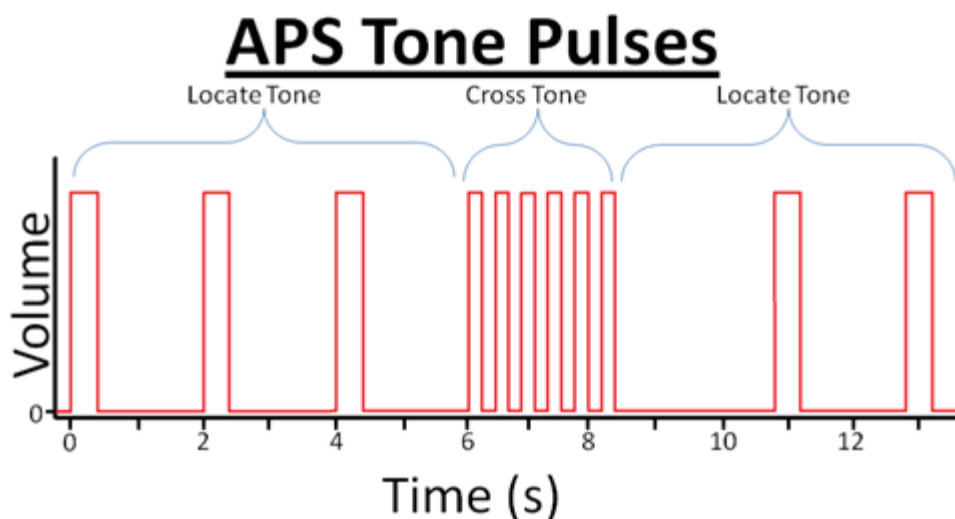
The audible signal produced consists of a locator tone and a walk tone. A pedestrian level locator tone emits a constantly pulsing sound at 30 pulses per minute with each pulse lasting around 400 milliseconds. Copenhagen uses a pitch of 880 Hz or one octave above the standard concert A pitch, which is the current standard for Denmark (Vejdirektoratet, 2006). In Frederiksberg, they opted for a percussive “knocking” sound. Most crossing signals in Copenhagen are timed so most systems do not need to be activated with a button press (Bjerremose, Frederiksen and Kreutzfeldt 2010). For intersections that do require button activation, the button is located on the device emitting the locator tone. This allows the user to easily find the button. When it is time to cross, both the Copenhagen and Frederiksberg tones switch to different signals. In both cases the pitch is the same as the locator tone, though the pulse rate of the walk indicator is five times that of the locator tone or 150 pulses per minute. Each pulse is half as long or 200 milliseconds long (Harkey et al., 2007). Figure 21 shows how the length and frequency of pulses changes with respect to the signal, although the length each tone is played for has been shortened for clarity.

Figure 21: Different APS tone pulses (Harkey et al., 2007)

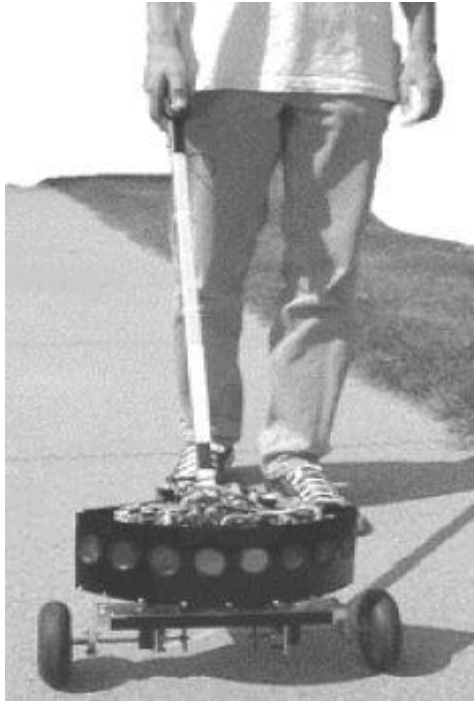
Navigation technology for the blind has taken many forms. The white cane has been a standard for advanced warning of surface topology and has the added benefit of being lightweight and inexpensive. One drawback is that it takes over 100 hours of training to become proficient at using a white cane for navigation. Some alternatives that have been explored include electronic travel aids or ETAs. These often use a laser or ultrasonic beam to detect obstacles. The location of obstacles is communicated to the user in a variety of ways. The *Mowat Sensor* is a handheld device that vibrates faster as it is pointed at an approaching object. The *Nav Belt* is an array of sensors worn around the waist that transmit signals into stereo headphones depending on the optimal direction of travel. The *Guide Cane*, as seen in Figure 22, uses a similar array of sensors but is connected to a wheeled cart at the end of a cane that steers itself to avoid obstacles (Shoval, Ulrich and Borenstein 2001). There are advantages and disadvantages to each of these systems when compared to the white cane. For example, while the Nav Belt and the Guide Cane might reduce the cognitive load for the user, they would be very expensive, bulky and would only detect large obstacles rather than the surface detail that white cane feedback provides.

**Figure 22: Guide cane (Shoval, Ulrich, Borenstein, 2001)**

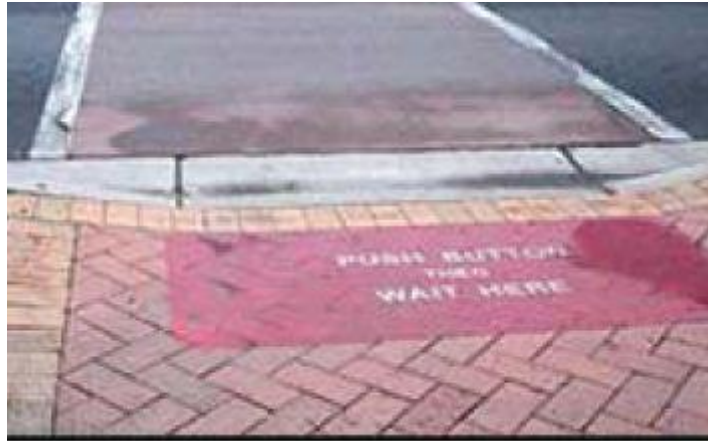
Another type of system that has been used for many years in a variety of traffic applications is the piezoelectric sensor. This works on the principle of a particular material changing its electric properties when a pressure is applied. In this case, the piezoelectric sensors are placed under a mat or the paving at a corner and detect when a pedestrian is standing in the correct location. The United Kingdom and Australia have used these sensors for a number of intersections as shown for an Australian intersection in Figure 24 (Shoval, Ulrich and Borenstein 2001).

**Figure 24: Piezoelectric sensor under painted area at a curb cut (Stiendel, 2008)**

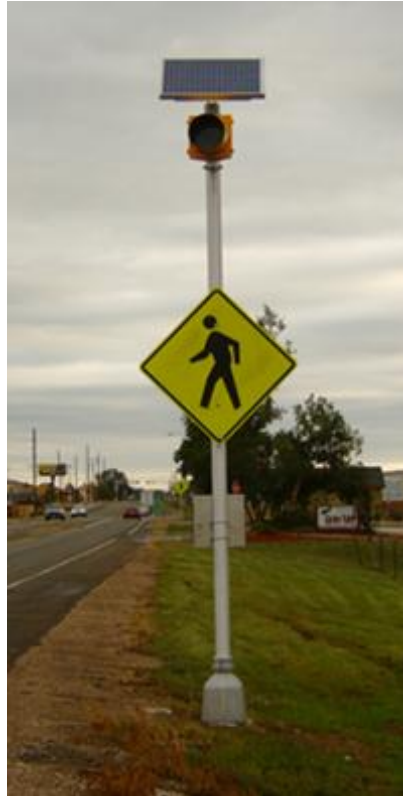
These wireless systems are already in use in the United States for connecting traffic signals from different intersections together. Introducing wireless technology has saved Los Angeles \$7 million across over 500 intersections, plus hundreds of thousands of dollars per year in telephone line leasing costs (Leavitt, 2009). Cost savings is much greater when connecting distant intersections than when connecting devices located in the same intersection, but wireless technologies can still be used for within-intersection connections. Figure 25 shows a pedestrian signal pole placed up the road from the intersection, used to give drivers advance warning of pedestrian activity. A pedestrian crossing sign is mounted on the pole along with a caution light wirelessly connected to the intersection up ahead and powered using a solar panel.

Figure 25: Wireless pedestrian warning sign (Northwest Power Co., 2010)

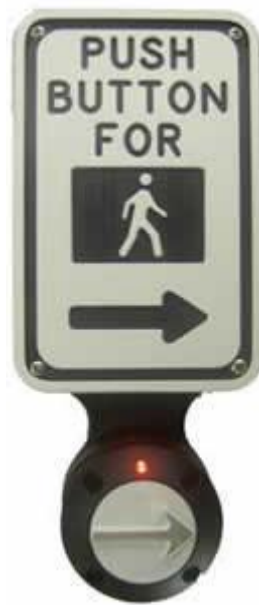
Campbell Company is known for its accessible pushbuttons for pedestrian crossing signals. The “Advisor” shown in Figure 30 is a pedestrian-level mounted system. A locator tone (800 Hz for 0.1 seconds every second) guides the user to the pushbutton to activate the signal. When the button is pushed, another tone is sounded that indicates that the button was successfully pressed. By pressing the button for an extended period of time the walk signal period can be extended and a message tells the user the location of the intersection. When it is appropriate to cross the street, an audible signal is played and the tactile arrow vibrates. The audible signal can be a chirp, a cuckoo or a message that says, “(Street name) walk sign is on to cross.” The volume of both the locator tone and the walk signal adjust to match the ambient sound (Campbell, 2008).

**Figure 30: Campbell Company "Advisor" APS (Campbell, 2008)**

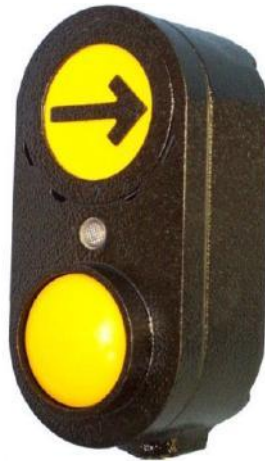
the defaults include a chirp for east/west directions and a cuckoo for north/south or a verbal message saying, "Walk sign is on." Special sounds or messages can also be played to indicate trains, emergency vehicles or other alerts. The volume can be adjusted from 0-90 dB at one meter. After initial adjustment, the signal automatically adjusts to stay 5 dB above the ambient noise level. The different features of the APS can be programmed from a wireless, handheld device (Novax, 2005).

Figure 31: Novax "SoundSafe™" (Novax, 2005)

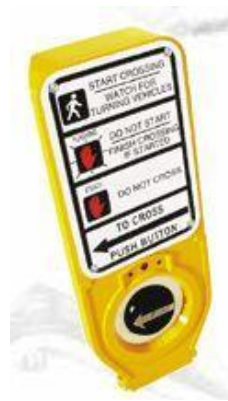
The Polara “Navigator” shown in Figure 33 has a wide variety of programmable options. The device uses a locator tone and has a tactile arrow on the pushbutton. There is also an optional message that can be played when the activation button is pressed that indicates the direction of travel, i.e. the street name and any other information that might need to be indicated. When it is appropriate to cross, the arrow vibrates and a “walk” signal is played. The “walk” signal can consist of a variety of tones or a customizable verbal message. Near the end of the crossing phase, a countdown tone is played or a countdown message. All of these verbal messages can be recorded in up to three languages that can be chosen. All sounds adjust to the ambient noise levels, but a maximum and minimum can be set (Polara, 2005).

**Figure 33: Polara "Navigator" (Polara, 2005)**

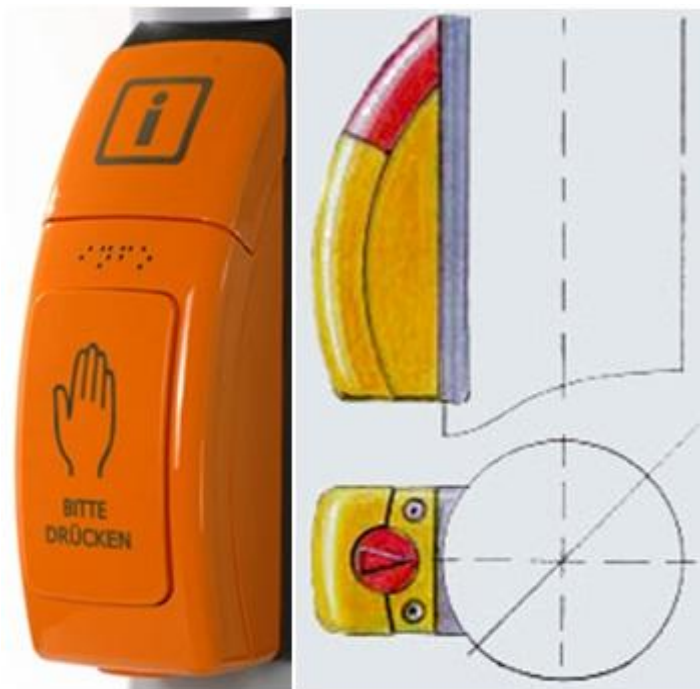
RTB is a Berlin-based APS manufacturer who has also supplied Denmark with some of its products. Their system, the "Berlin", is comprised of two components: the pushbutton box and the acoustic signal transmitter. The pushbutton box has many models, and one of them is designed specifically for the visually impaired. It has an actual press point, as compared to the other models, which only have a sensor. With this model, the walking phase may be extended and a special signal may be activated. The word "Info" is written in Braille above the pushbutton. On the underside of the box is a vibrating tactile arrow. It must be noted that the features of this model may be combined with other models (RTB 2010).

Figure 35: RTB "Berlin" Pushbutton (RTB 2010)

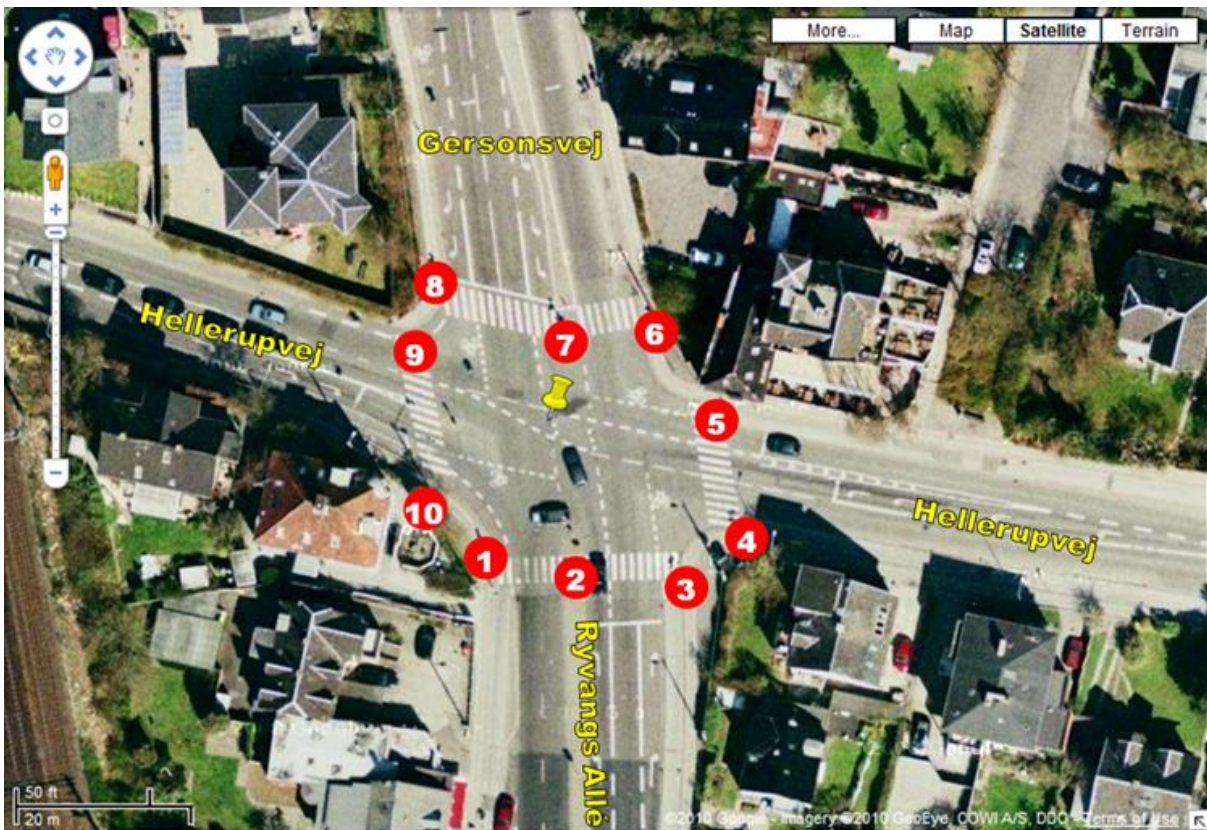
Figure 40: Top down view of the intersection of Ryvangs Alle and Hellerupvej (Google Maps, 2010)

- Vibrating APS at a moderately low volume.
- At Unit 5, the sound is shut off but the vibration makes the pole emit sound.
- At Units 6, 7, and 8, the APS is not on the pedestrian signal pole. It has its own pole, located to the outside of the intersection.
- Unit 8 had a tactile arrow that was not positioned correctly.
- Significant amounts of turning traffic, including buses, make this intersection challenging and more dangerous to cross.
- Although the western crosswalk (shown on the left) is APS-equipped, Hans chose to take the other three crosswalks instead. He described that crosswalk as the most dangerous one at the intersection. However, his route kept him close to parallel traffic: a technique we discussed with an Orientation and Mobility Specialist named Lisbeth Hallestad.

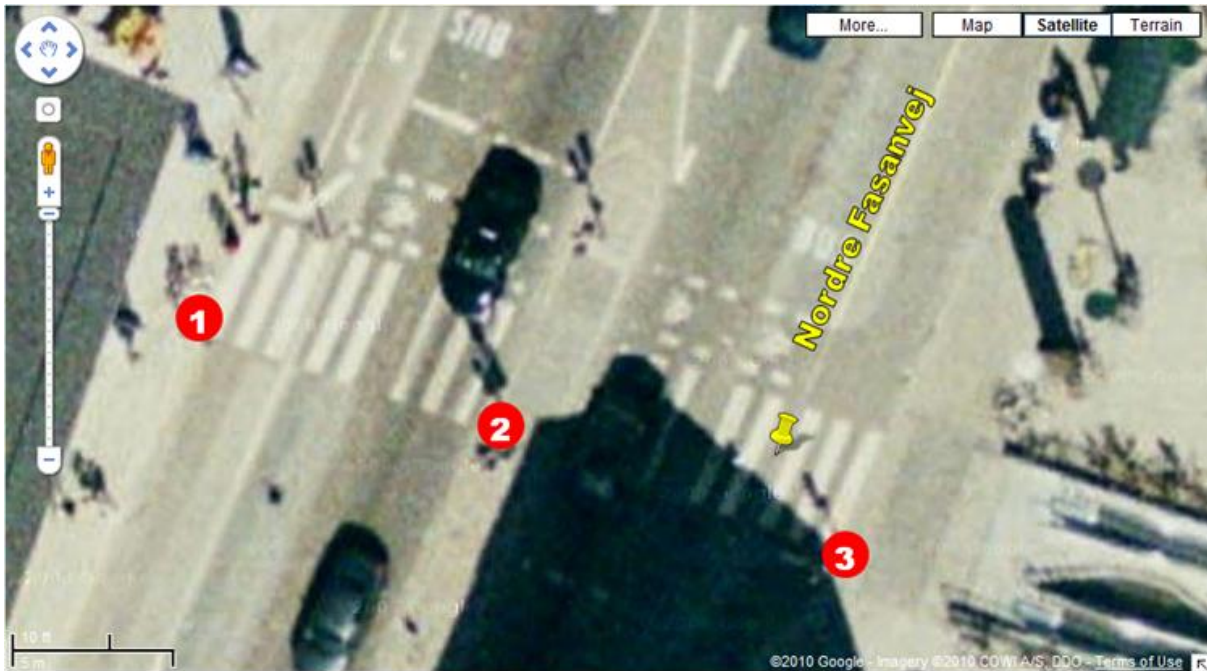
**Figure 45: Top down view of the intersection of Nordre Fasanvej at Fasanvej Station (Google Maps, 2010)**

Christian is a very experienced independent traveler. Though this particular intersection crossing was fairly simple, this was only the second time Christian had crossed it. One complexity to the intersection is that there is no traffic that is parallel to the direction of travel. This would have made the crossing difficult without an APS with the rule that one should only ever cross with the flow of parallel traffic. Also, if one were walking along the sidewalk, it would be very difficult to know where precisely the crossing was since there is no cross street at which to stop and turn.
