Project Number: JYP - 0909

## Major Qualifying Project

# Improving Drinking Water Quality on Barro Colorado Island, Panama

March 12, 2010

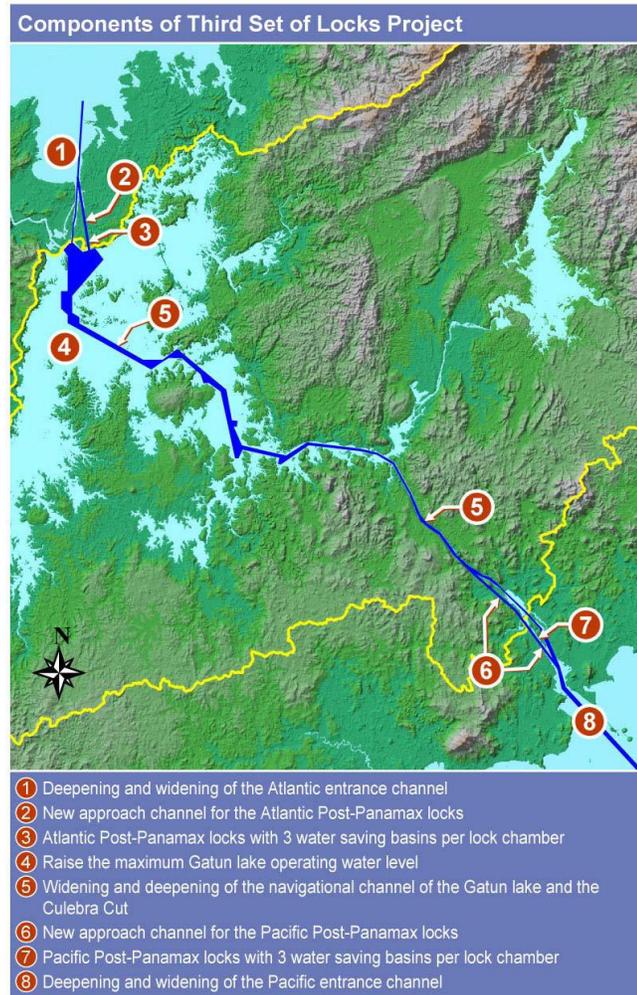
Figure 2: Panama Canal Expansion (Panama Canal Authority, 2006a)

The expansion project consists of adding two new sets of locks to the canal system as well as approach channels for the new locks (see Figure 2). One set of locks is on the Pacific side of the Canal, east of the Gatun locks. The second set of locks will be on the Atlantic side south west of Miraflores Locks. The new locks will use gravity to bring water in and out of them, like the existing locks, but will have water basins to reduce the quantity of water released to the ocean when the locks are drained, thus reducing the volume of water needed from Lake Gatun. The new set of locks will use tug boats to position and move vessels instead of locomotives. The expansion project also includes the widening and deepening of all the existing channels of the canal and a proposed bridge or tunnel at the Atlantic end of the canal. Lake Gatun's water level will also be raised resulting in an increase in its useable water reserve capacity, allowing the locks to be used more frequently so that the canal can handle more traffic (Panama Canal Authority, 2006a).

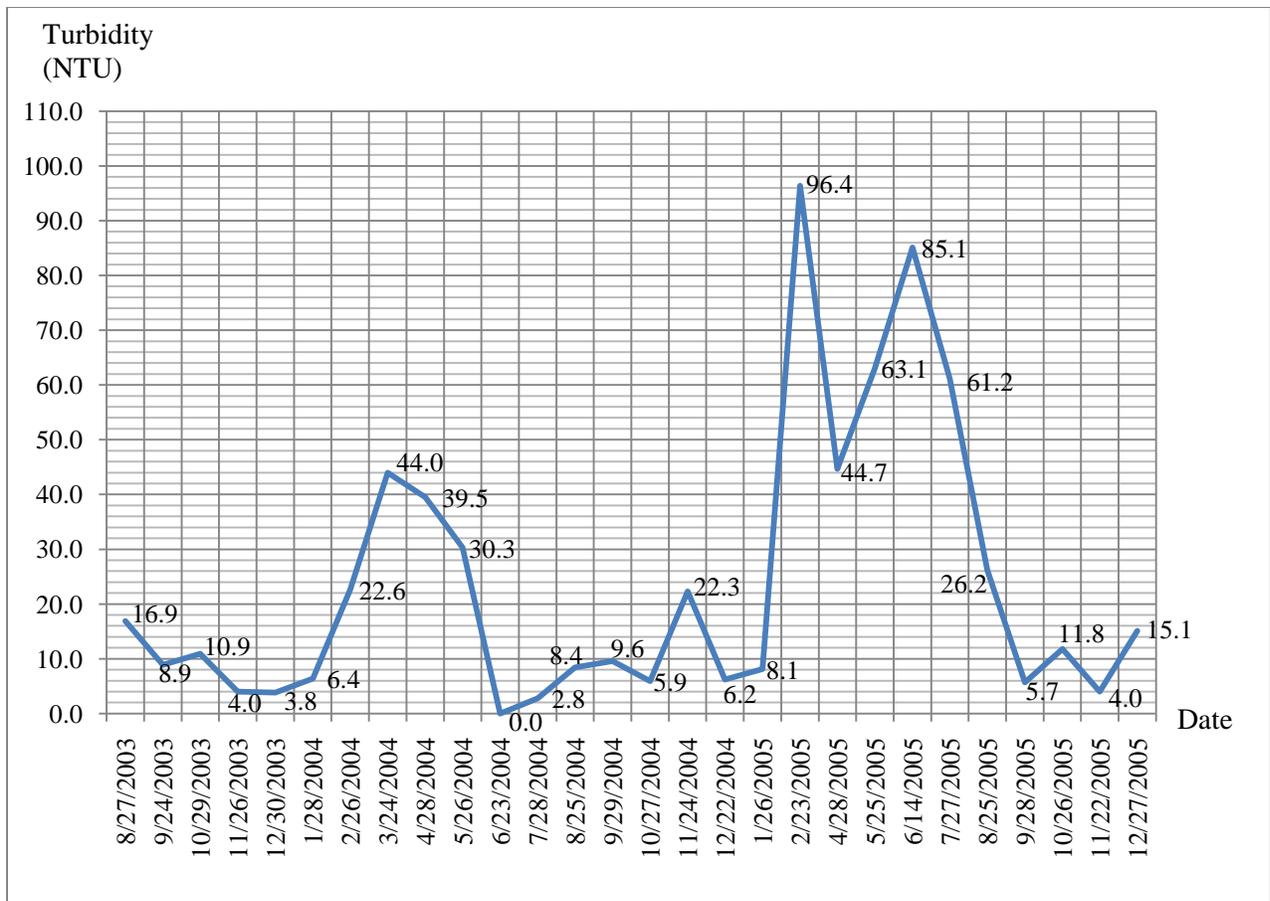
Figure 5: Graph of Turbidity Data in Lake Gatun at ACP Water Testing Point, August 2003 – December 2005

Turbidity data for this location near the surface of Lake Gatun for the available dates in 2003 to 2005 are shown in Figure 5. Throughout this time period, the turbidity levels varied greatly and were generally well above the Panama drinking water quality standard of 1.0 NTU. Peak turbidity levels occurred between March and April 2004 (44.0 and 39.5 NTU, respectively), in February 2005 (96.4 NTU), and June 2005 (85.1 NTU).

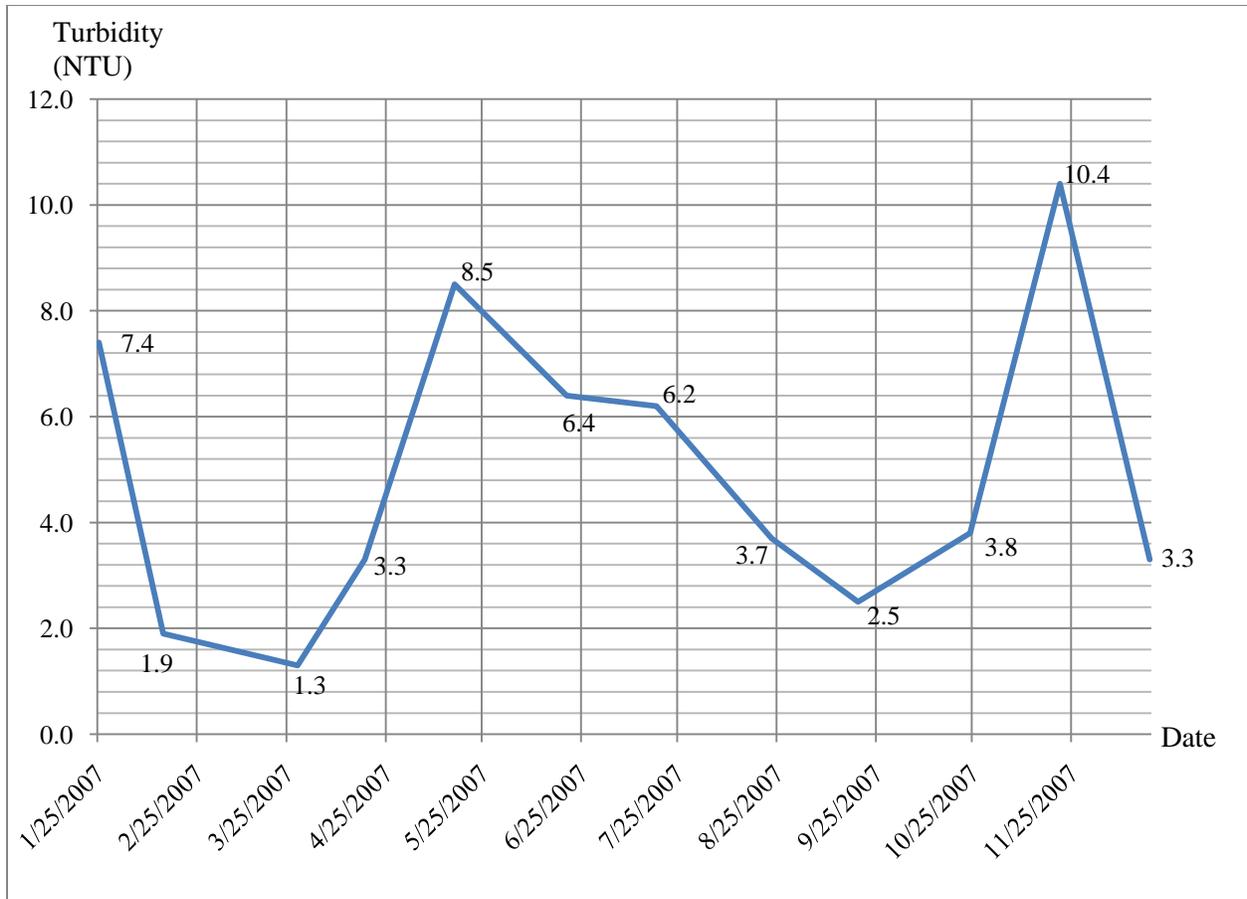
Figure 6: Graph of Turbidity Data in Lake Gatun at ACP Water Testing Point, January 2007 – December 2007

Turbidity data for this location near the surface of Lake Gatun for 2007 are shown in Figure 6. The turbidity levels near the water intake near the surface of Lake Gatun varied from 1.3 NTU to 10.4 NTU. Peak turbidity levels occurred in January (7.4 NTU), May (8.5 NTU), and November (10.4 NTU). These peak levels are significantly lower than peaks observed from 2003 to 2005.

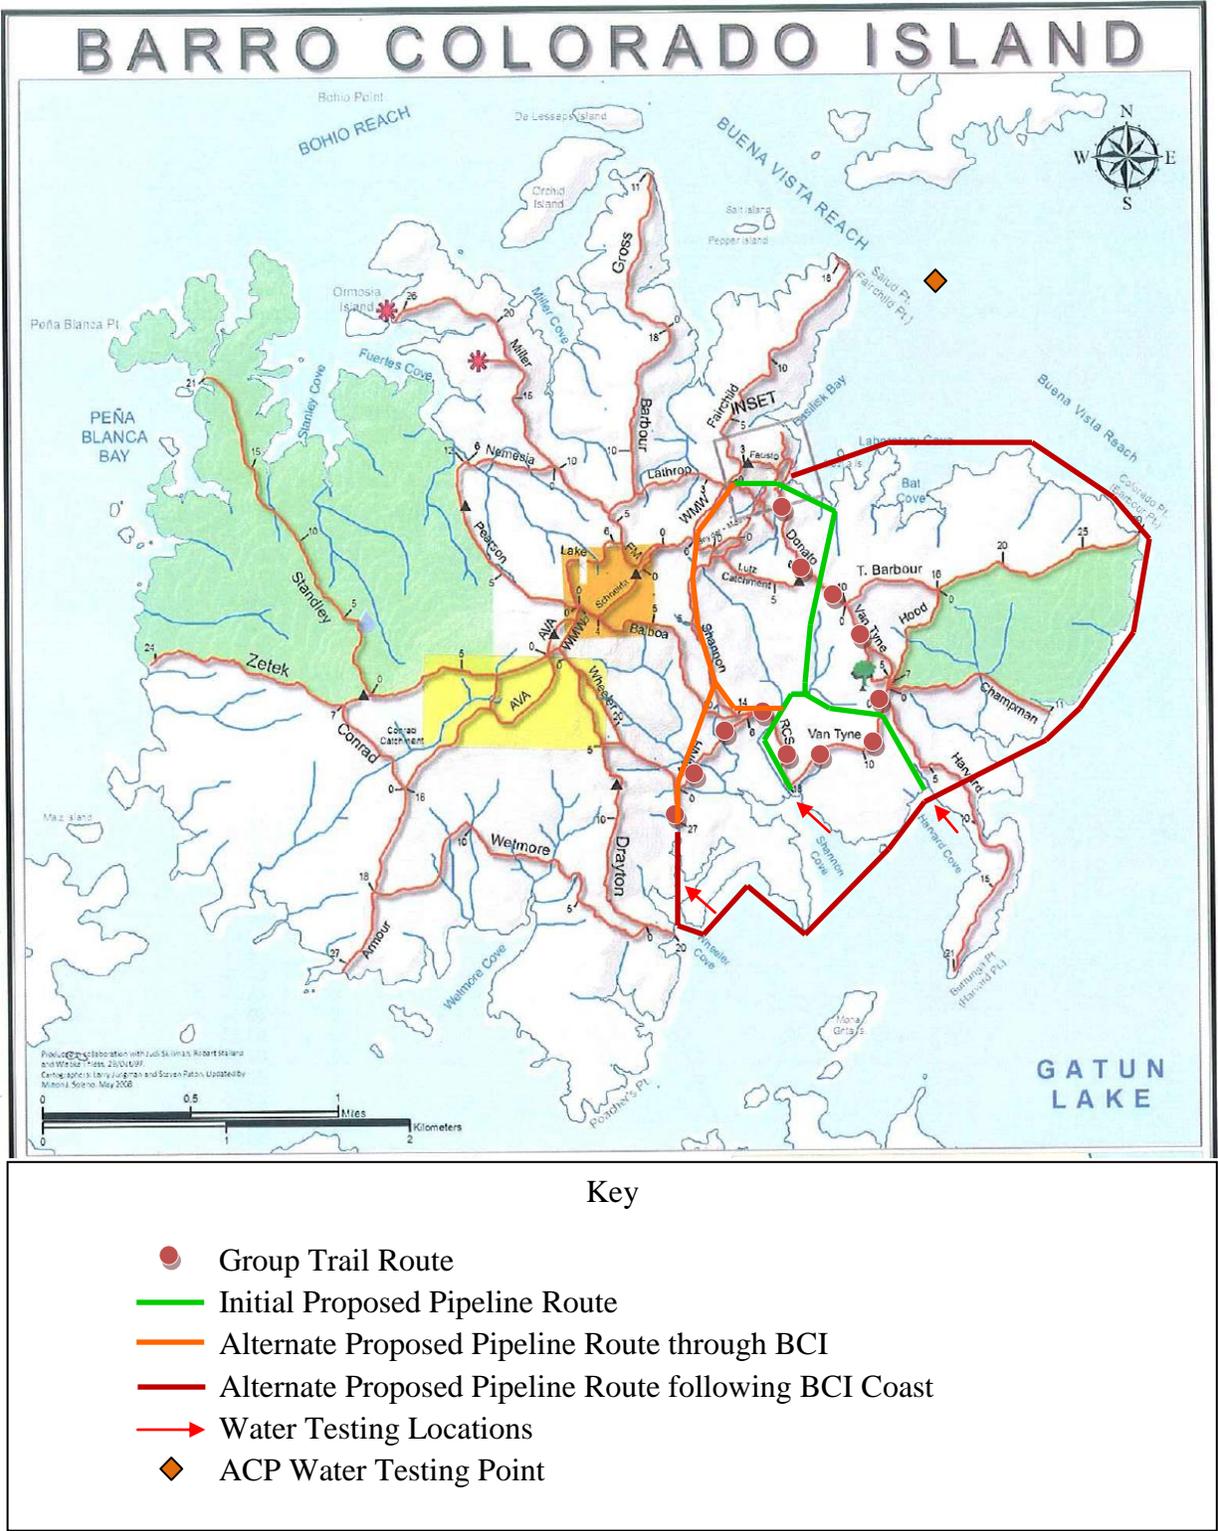
Figure 7: Map of Pipeline Routes on Barro Colorado Island<sup>7</sup>

During the third visit to BCI, the group conducted an investigation of possible routes for a pipeline connecting a potential new water intake to STRI's current water treatment facilities. Accompanied by STRI's Head of Trail Maintenance, Apolonio Valdés, the group traveled along Donato Trail, Van Tyne Trail, Shannon Trail, and American Museum of Natural History Trail as shown in Figure 7. The three proposed intake locations were visited, and the terrain over which a new pipeline would travel was viewed first hand. The group verified that the initial proposed pipeline routes, as shown in Figure 7, were suitable. The valley that the pipelines would follow was viewed from the trails that the group traveled and proved to be the lowest elevation in the area. Mr. Valdés suggested another alternative route, as indicated by the orange lines on the map

of BCI. This route establishes Wheeler Cove as the intake location. Mr. Valdés suggested this intake location because it has experienced less impact from the dredging activities than the other proposed locations. Mr. Valdés has been working on BCI for nearly 30 years and as a result, he is knowledgeable about the terrain on the island. His advice concerning pipeline routes was given much weight by the group.

In order to calculate the required length of the pipes for each route, the profiles shown in Figures F-1 and F-2 were created using AutoCAD 2010. Each route's elevations and horizontal distances were derived from the BCI trail map shown in

Figure 7. Note that each pipeline profile can be divided into individual segments. Each segment contains a triangle and rectangle (an example is outlined in red in Figure F-1), in which the hypotenuse of the triangle represents the required pipe length of each segment. The total required pipe lengths for the Shannon Route and Wheeler Route are 1,881.56 meters and 2,001.52 meters, respectively.

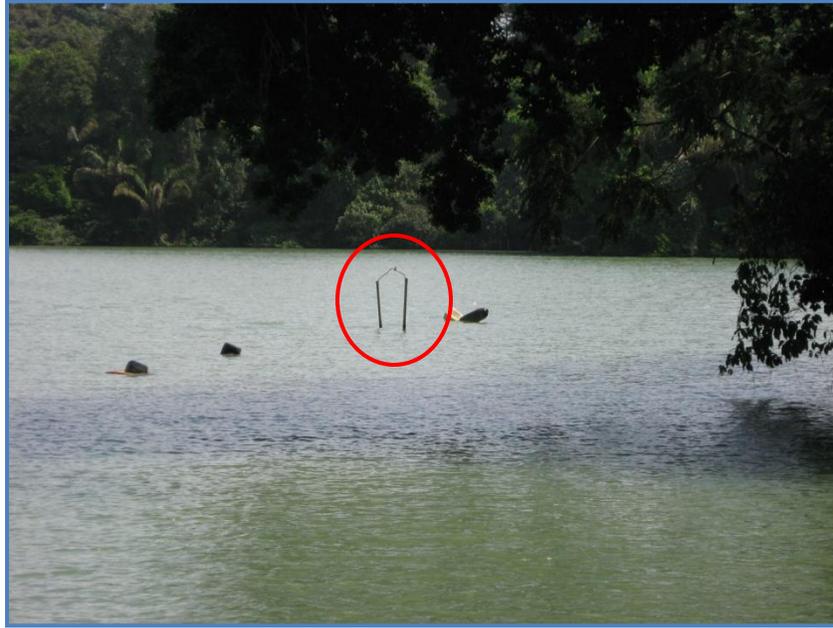
Figure A-1: Water Intake in Lake Gatun

The water intake is in the same cove that STRI's dock and main facilities are located. It consists of a 2 inch diameter PVC pipe that starts from a location about 100 meters from the entrance dock, with two stakes that hold the pipe in place. The intake is about 1,200 meters from the canal channel in Lake Gatun (Panama Canal Authority, 2009d). The intake pipe reaches an automatic electric pump station that contains two centrifugal pumps in operation, each 80 gallons per minute, 25 HP, with a pressure gage (Flores, 2008). The pipe then leads to a prefilter mechanism that is currently not in operation. The prefilter system was installed between May and June of 2009 in order to mitigate the suspended solids content in the water before it enters a concrete storage tank (Broce, 2010). STRI began using a 25 micron pore size for the prefilter, but since this size was not adequate to collect dissolved solids, it was changed to a 10 micron filter which was provided by ACP. For this filter pore size, the influent flow had a turbidity reading of 100 NTU and the effluent flow had a reading of 53 NTU (Panama Canal Authority, 2009d), which is well above the Panama drinking water quality standard of 1.0 NTU.

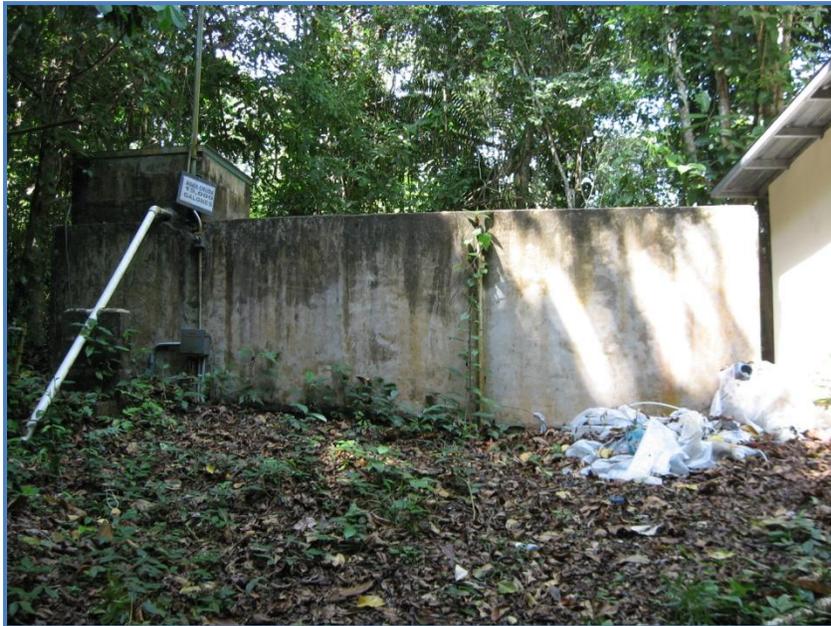
Figure A-6: 15,000 Gallon Concrete Tank

After the prefilters, the water enters a concrete storage tank with a 15,000 gallon capacity. The effluent location of the concrete tank was originally at the top of a 1.5 foot vertical PVC pipe extending from the bottom of the tank (Dillon, 2010a). This allowed some solids to settle to the bottom while water from the middle portion of the tank, above the pipe (that had less suspended solids), was taken through the pipe for further treatment. Over time, the PVC pipe has deteriorated and is no longer present. There is a buoy in the concrete tank that senses when the tank is full, at which point the pumps, as previously mentioned, automatically stop operating. While water fills the tank, the pumps alternate in operation. The buoy also senses when the tank is low enough to accept more water (Campos, 2010). The water flows from the concrete tank through a 2 inch diameter PVC pipe to an Amiad Type AMF 36 filtration system consisting of three units, which can handle flows up to 30 cubic meters per hour (approximately 7,900 gallons per hour) (Amiad Filtration Systems Ltd., 2010). The filters were installed between May and

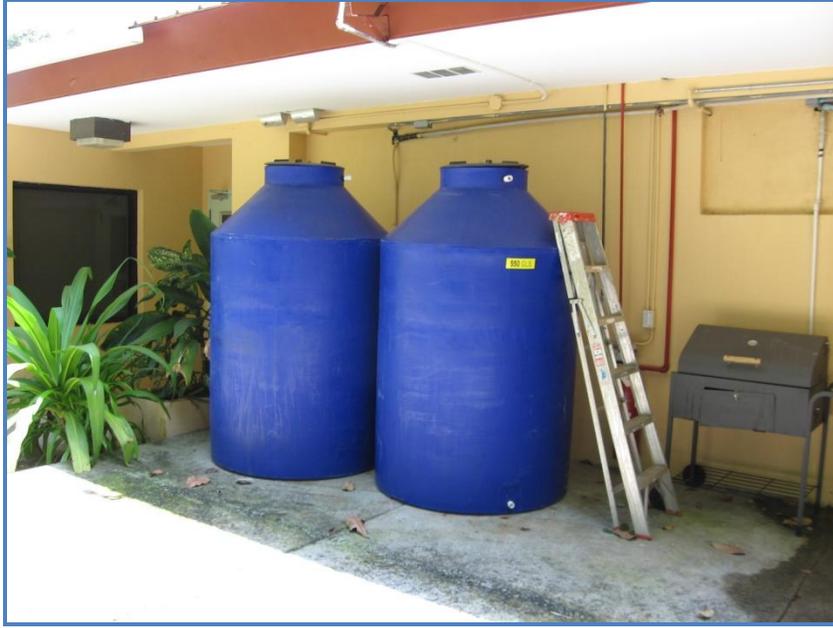
Figure C-3: Photo of 550 Gallon Tanks for Storage of Potable Water on BCI, Jan. 13, 2010

- A mechanical system for the storage and provision of water to STRI's kitchen. The system will consist of the following:
  - Centrifugal pump, 30 gallons per minute, 1 HP
  - Centrifugal pump, 10 gallons per minute, 1.5 HP
  - Two 550 gallon plastic tanks
  - 35 gallon hydropneumatic tank
  - Pressure switch
  - 1.5" PVC pipe, SDR 26
  - 0.5" Hose keys
  - Pipes and valves accessories
  - Tablet chlorinator

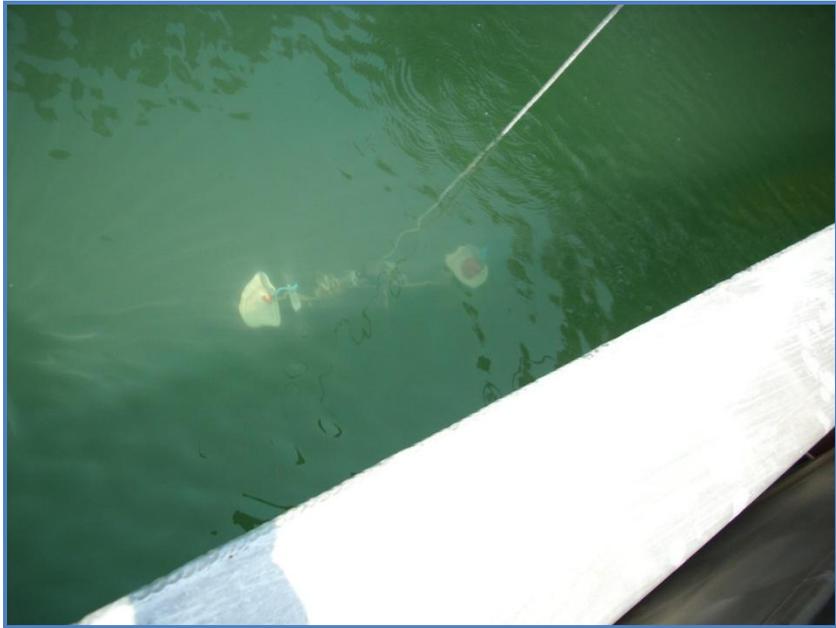
Figure D-6: Water Sample Collection Performed with Van Dorn

In order to conduct the water testing, the group used a small motorboat to travel from STRI's dock to the test sites. With the aid of José Simmonds, a water quality specialist from ACP, the group collected samples from the three sites off of Harvard Point and near the intake. Conditions at the testing sites were recorded, such as depth, water characteristics, and distance from the shore. At each site, a Van Dorn sediment sampler was used to collect water samples at the following depths: 1.0 meter from the bottom, the middle of the total depth, and 0.5 meters from the surface. As per the Gaceta Oficial N° 23,941, each sample container was rinsed with the water sample prior to collection (DGNTI; COPANIT, 1999b). Upon returning to the dock, the samples were stored on ice in a cooler and then transported to ACP's water quality laboratory located in one of their main offices. From the laboratory report, the group acquired temperature, pH, turbidity, and TSS concentration results for each sample.
